First double geomembrane liner *40 years later*

The first double geomembrane liner 40 years later

By J.P. Giroud and J.P. Gourc

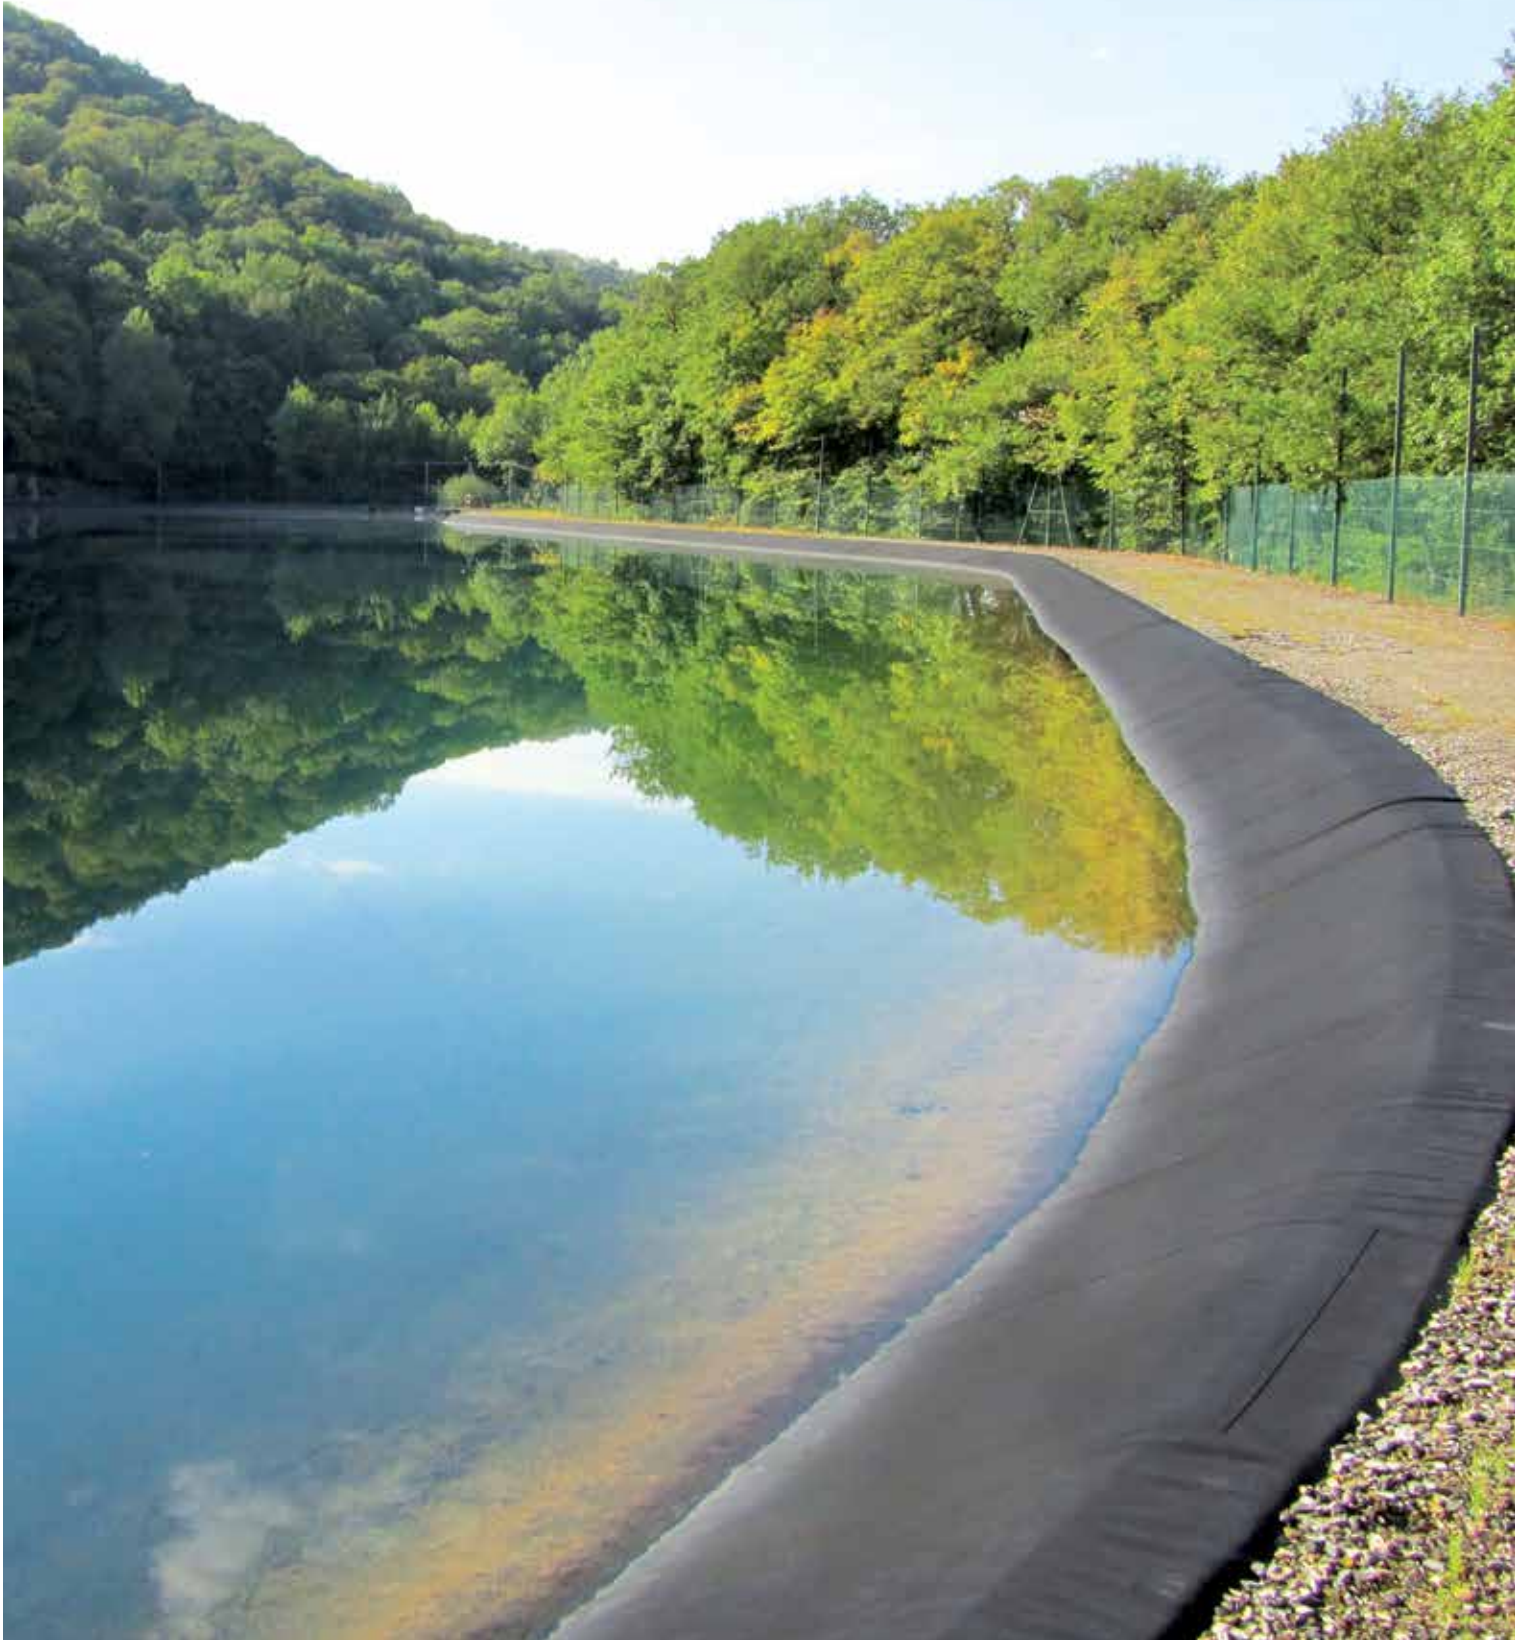
FIGURE 14 The reservoir in 2011, 37 years after construction and beginning of service.

The authors visited the site with A.L. Rollin in September 2011, 37 years after construction. The reservoir was full (i.e., the water level was 1m vertical below the crest) (**Figure 14**). The reservoir has never been emptied and the portion of butyl rubber geomembrane above water has been continuously exposed since 1974. As indicated above and in **Figure 3**, the emerged portion of the geomembrane, the only portion of geomembrane visible during the site visit, is reinforced with scrim.

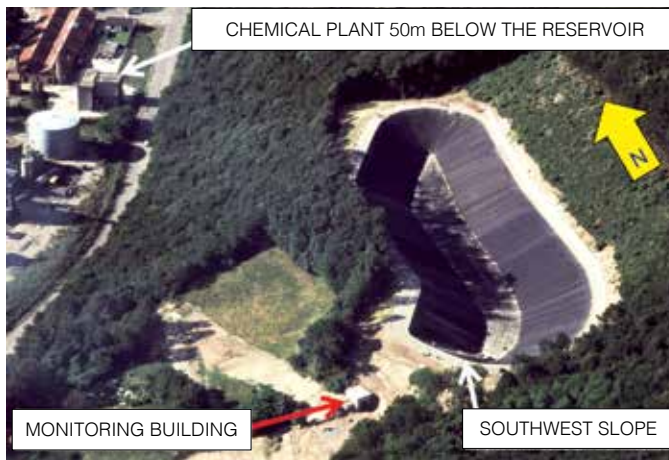
FIGURE 2 Aerial view at the end of geomembrane installation. The shape of the reservoir minimizes the impact of excavation on the stability of the east slope and the weight of the dike on the west slope. The reservoir proportions are distorted because the photo was taken at an angle (as evidenced by the fact that the intake structure on the 1V:2H southwest slope is hardly visible).

The authors also visited the monitoring building (**Figure 2**). The outlets of the two leakage removal pipes were completely dry.

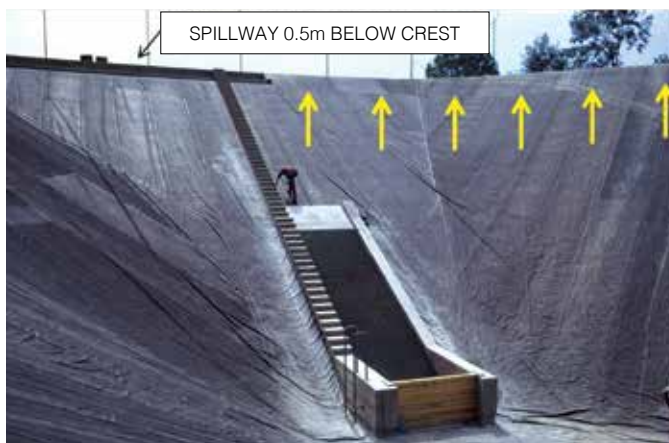
FIGURE 3 Southwest end of the reservoir showing: water intake structure, spillway, and butyl rubber geomembrane. The butyl rubber geomembrane is unreinforced, except at the top of the slope where a strip of reinforced butyl rubber geomembrane is used around the entire perimeter (except at the spillway) above the level marked by the yellow arrows and in the anchor trench.

No wrinkles due to thermal expansion were observed. The only wrinkles of the geomembrane were seen at the end of construction (**Figure 3**). They apparently resulted from installation and were due to the complex geometry of the reservoir.

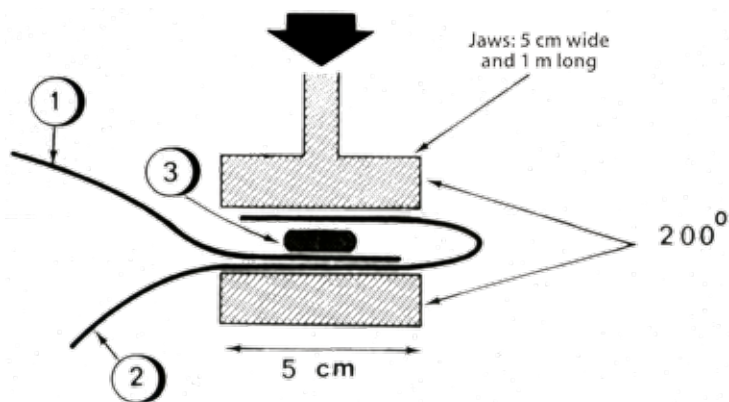
As seen in **Figure 12**, a 5cm-wide portion of geomembrane is heated at 200 C even though it is not actually seamed. There was some concern that this heating could cause premature ageing of a 5cm-wide zone of butyl rubber geomembrane parallel to the seams. This type of problem was not observed on the visible portion of the geomembrane.

FIGURE 12 Butyl rubber geomembrane seaming between panel ① and panel ②. A tape of nonvulcanized butyl rubber ③ inserted between the two panels is heated and pressed by the jaws at 200 C, which vulcanizes the tape thereby creating the seam. Finally, the jaws are open and the panel ② is unfolded. Original drawing from 1973.

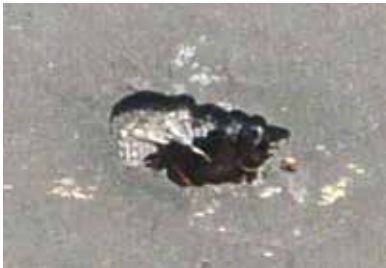
The butyl rubber geomembrane appeared to be in good condition. It did not seem brittle and it did not exhibit visible cracks. Only one hole (about 1cm²) was seen (Figure 15), at the south end of the reservoir, in the horizontal portion of the geomembrane between the top of the slope and the anchor trench. The reinforcing fabric (scrim) was visible at the edge of the hole. No other mechanical damage was observed.

FIGURE 15 Hole in the geomembrane with reinforcing fabric (scrim) visible on the left side of the hole.
