The 2023 Koerner Lecture

**FROM ZERO LEAK
AT END OF GEOMEMBRANE INSTALLATION
TO ZERO LEAKAGE
IN SERVICE**

By
J.P. GIROUD

Originally presented on 2023 February 07
Presented on 2023 May 18 as FGI webinar

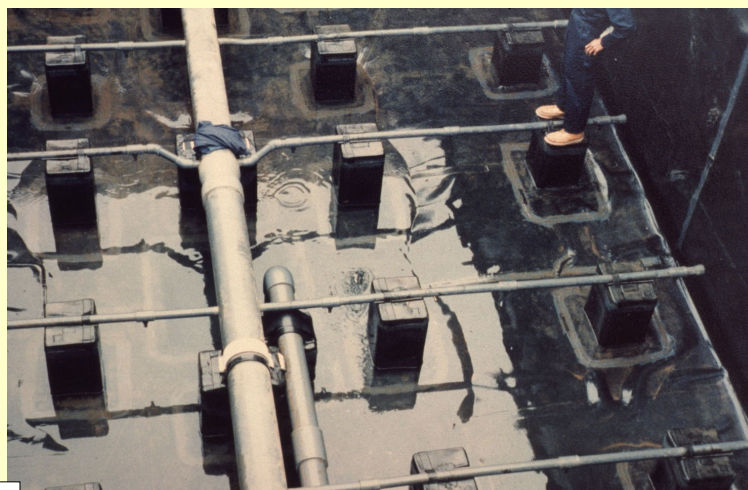
And the installed geomembrane . . .

. . . had **more than 100 holes.**

- The configuration of the reservoir was such that it was **inevitable to have many holes** in the geomembrane.
- Clearly, the cause of the holes was the **inadequate design**.

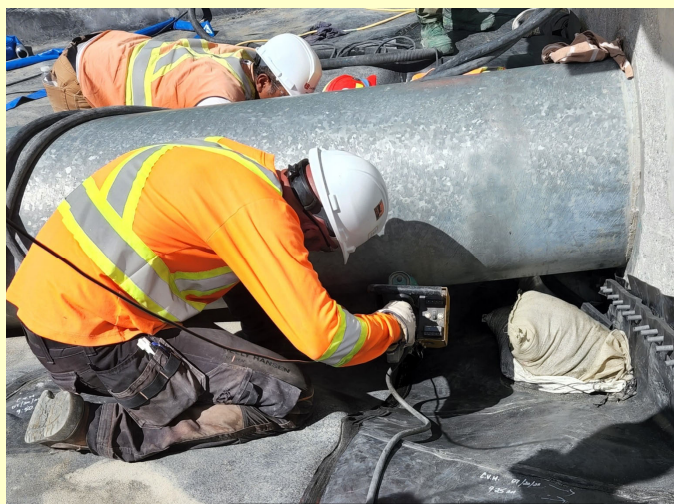
Here is an example, also in North America, but in 2022.

An acrobatic performance was needed to install the geomembrane.

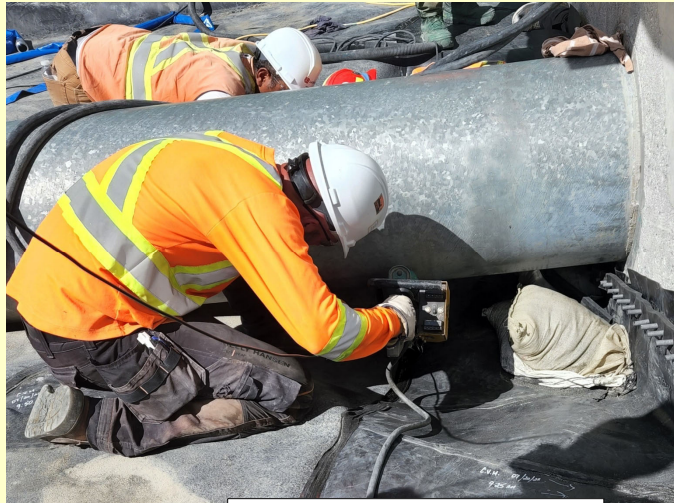
Excessive leakage occurred in this reservoir and **extensive rework** was necessary.

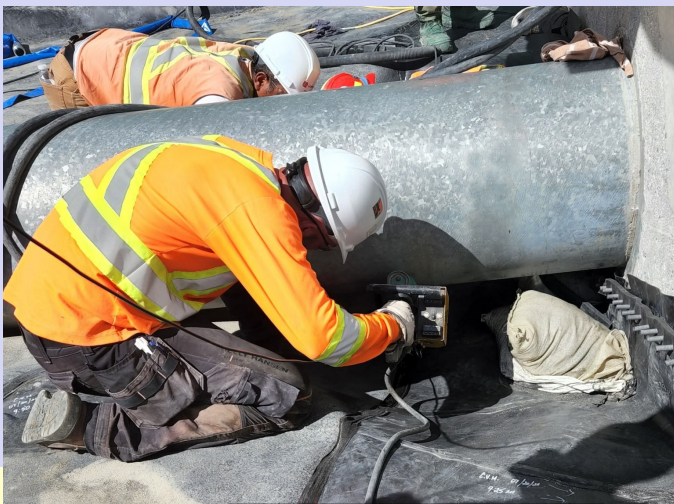
Thanks to the rework, the leakage was significantly reduced, but not reduced to zero, even though the installer was excellent and an expert field engineer was present.

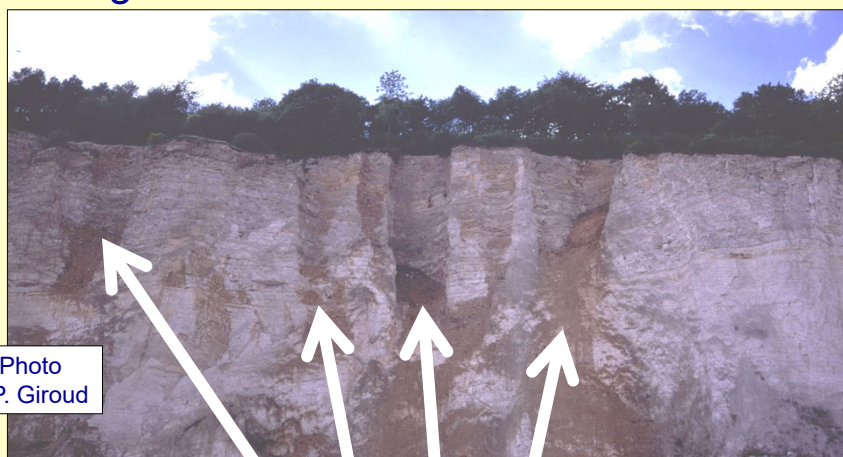
Here is the quarry showing a cross section of the karstic formation.

Numerous cavities could be observed.

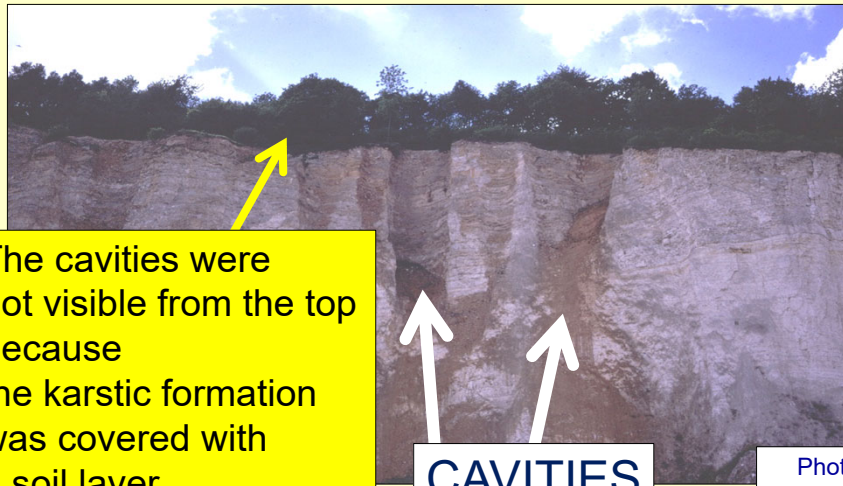
The reservoir was located on the top, behind the trees, not far from the quarry.

The cavities were not visible from the top because the karstic formation was covered with a soil layer.

The quarry was observed only when the failure of the reservoir was investigated.

At the design stage, there was **no geological study** and the quarry was not observed.

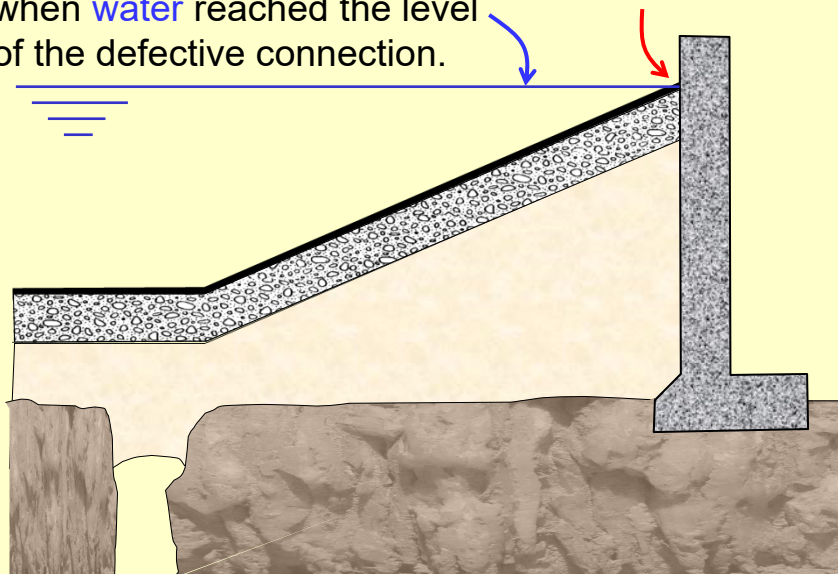
During the **first filling** of the reservoir, **leakage** occurred at a **defective connection** between the geomembrane and the **concrete structure**.

Leakage occurred

when **water** reached the level of the defective connection.

Defective connection

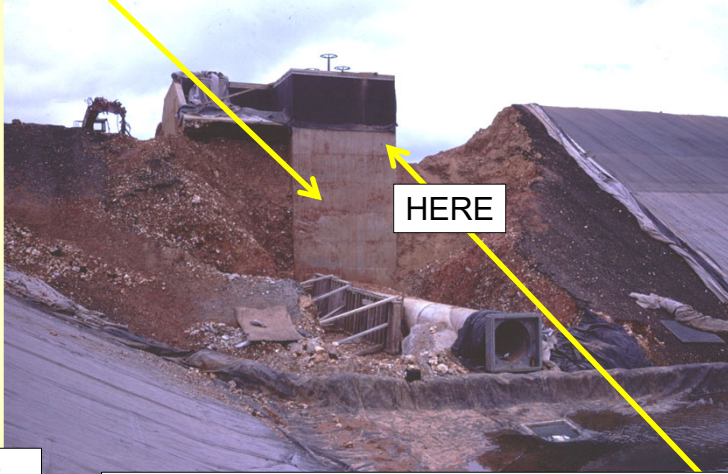
Here is a view of the failure area showing the concrete structure to which the geomembrane was attached.

HERE

The defective connection was here.

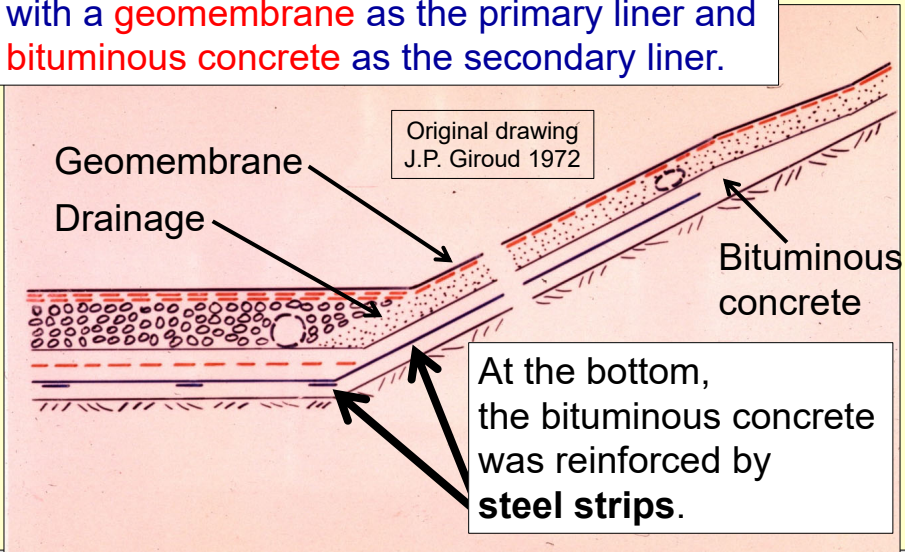
The adopted repair solution included both **double liner** and **reinforcement**.

The repair consisted in a **double liner** with a **geomembrane** as the primary liner and **bituminous concrete** as the secondary liner.

The **secondary liner**, by preventing water collected by the leakage collection and detection layer from infiltrating into the ground, was the **best way** to prevent the *same failure mechanism* from occurring again.

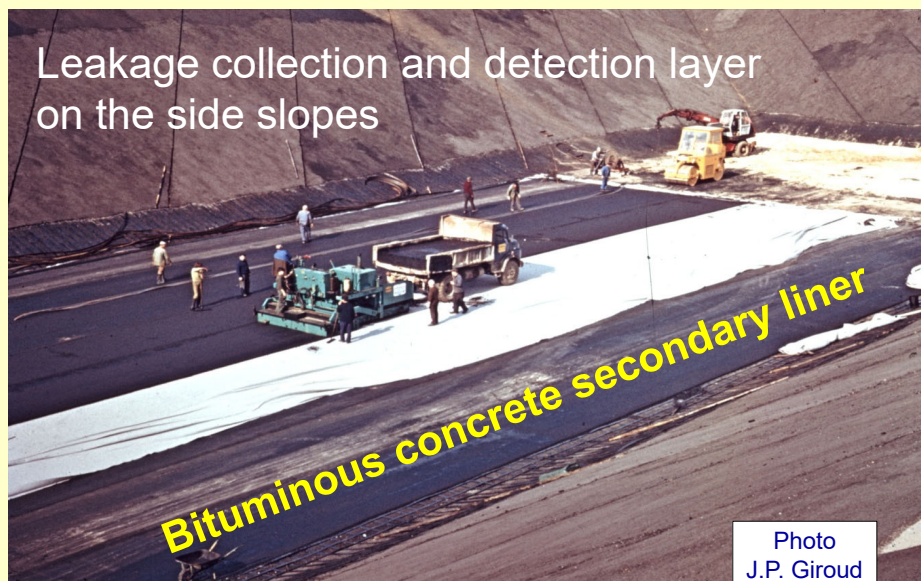
Leakage collection and detection layer on the side slopes

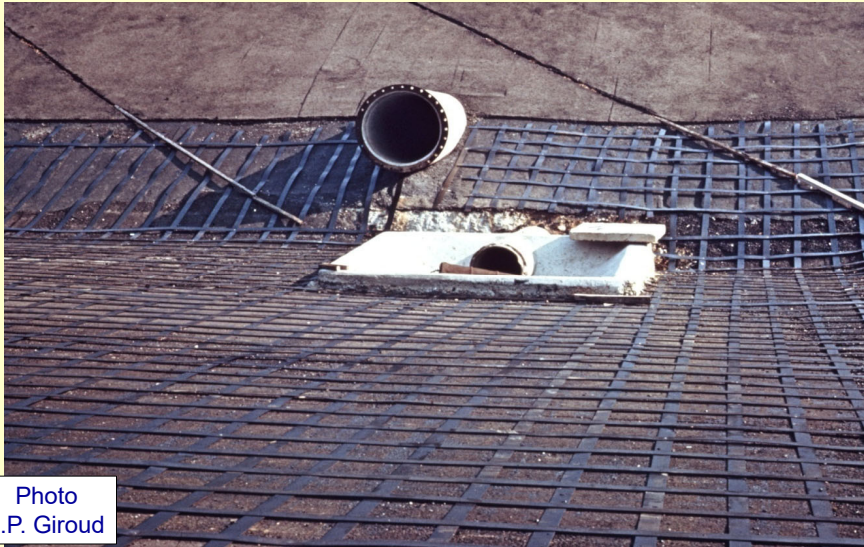
STEEL STRIPS USED TO REINFORCE THE BOTTOM

- The key aspect of the repair was the **double liner**, because it addressed the **cause of the problem**, which was *leakage into the ground*.
- The **reinforcement** only addressed the **consequence of leakage**, which was erosion of geomembrane support. (*It was used to reassure the owner who did not trust the double liner.*)

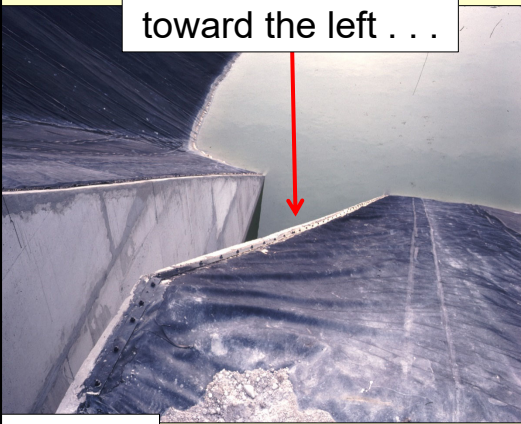
This wall moved toward the left . . .

. . . because it did not resist the active soil pressure.

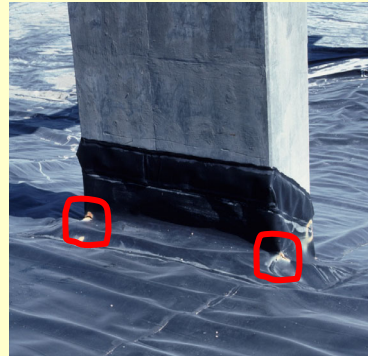
In addition to the risk of **stress concentration**, there is **another problem** with **right-angle corners**.

It is difficult to achieve a **watertight** connection between a geomembrane and a structure with **right-angle corners**.

Without watertight connections, the **zero-leak goal** at end of installation **cannot be achieved**.

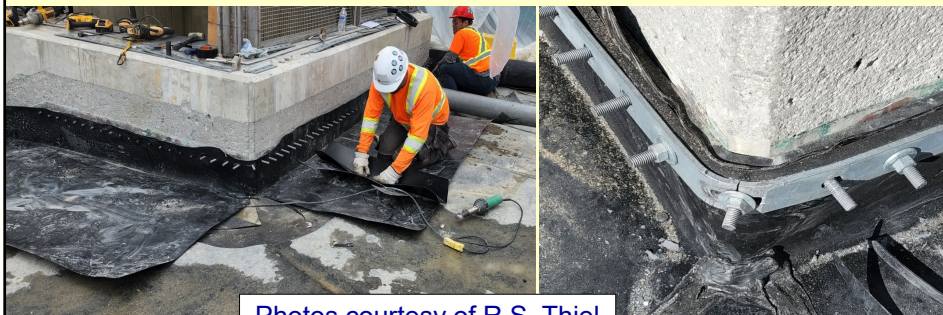
These photos illustrate the **amount of care** needed to attach a geomembrane to a concrete structure with **right-angle corners**.

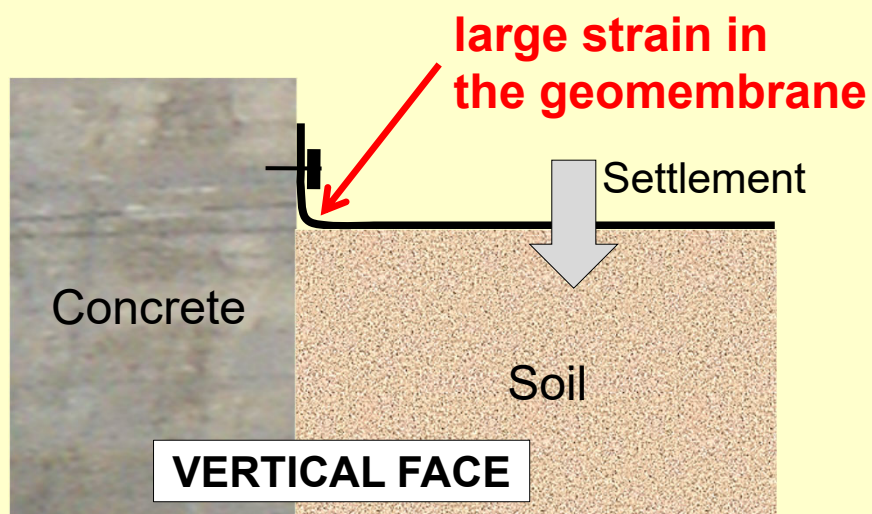
To **minimize differential settlement**,
it is recommended
to **avoid** rigid structures with **vertical walls**,
and
to design structures with **inclined walls**.

This concrete structure with **vertical wall** is inadequate
in case of soil settlement because of

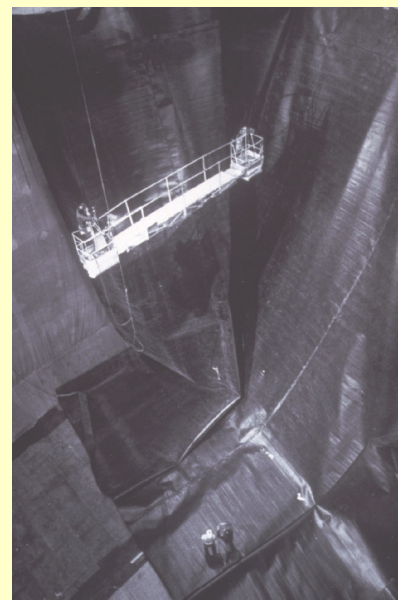
I was asked to design the liner for this extraordinary reservoir.

Due to the solubility of the salt, I recommended a **double liner** with two geomembranes.

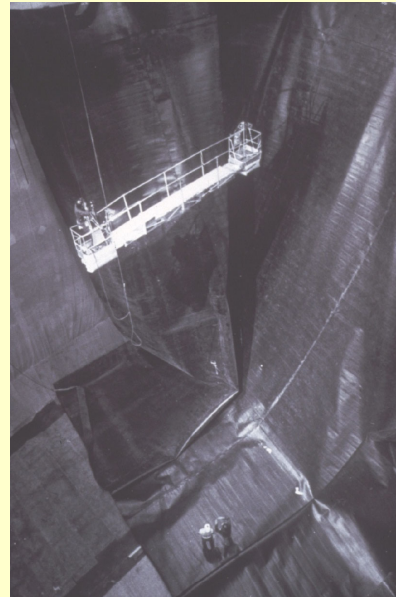
For the leakage collection and detection layer between the two geomembranes, I selected a **geonet** (a new geosynthetic at that time, 1980) because (contrary to gravel) it is **not radioactive** and it could be **installed vertically**.

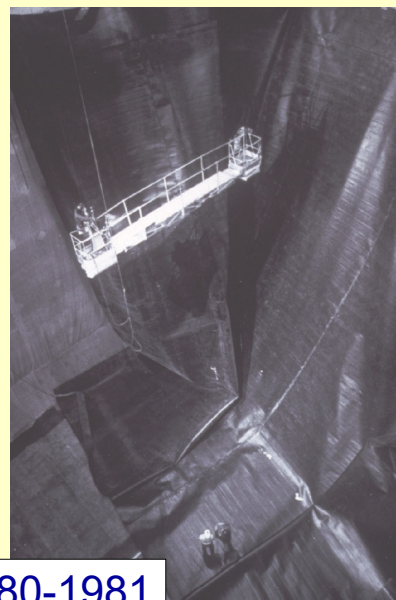
This was the **first use** of a **geonet** for a leakage collection layer and the **first entirely geosynthetic** double liner system.

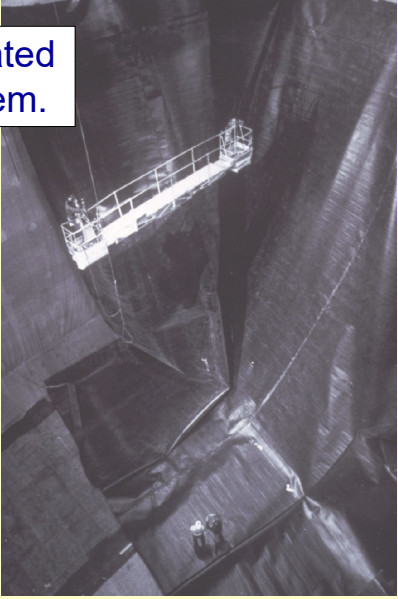
The reservoir had **right-angle corners**.

This is another example of structural design done **without taking into account** the requirements of geomembrane installation and performance.

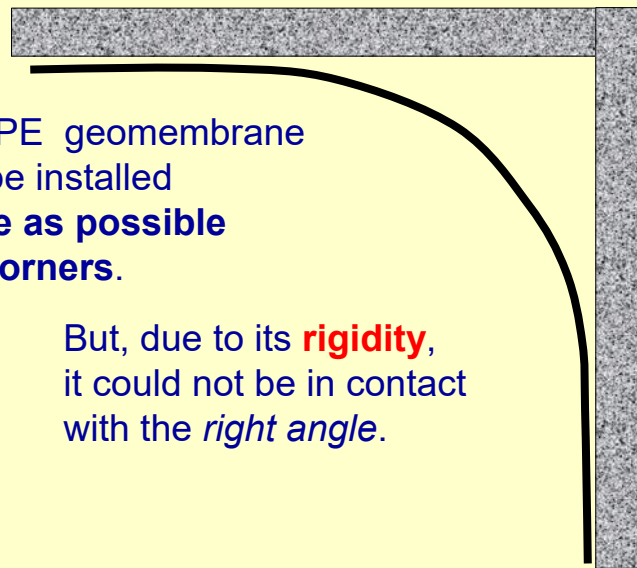
The HDPE geomembrane
was to be installed
as close as possible
to the corners.

But, due to its **rigidity**,
it could not be in contact
with the *right angle*.

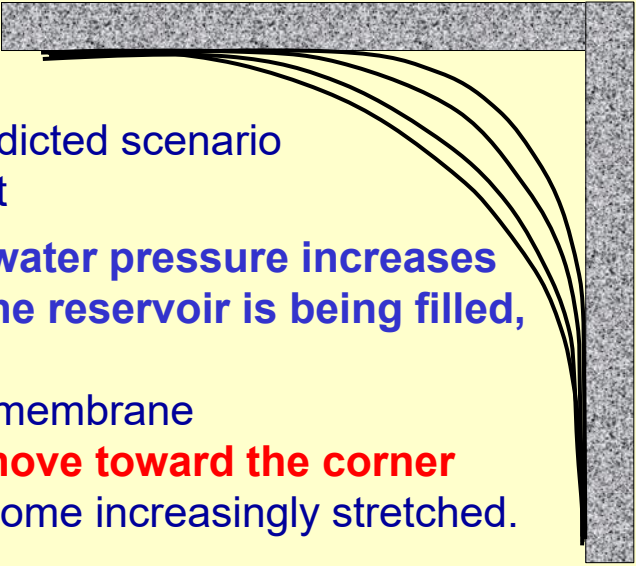
The predicted scenario was that as the water pressure increases when the reservoir is being filled, the geomembrane would **move toward the corner** and become increasingly stretched.

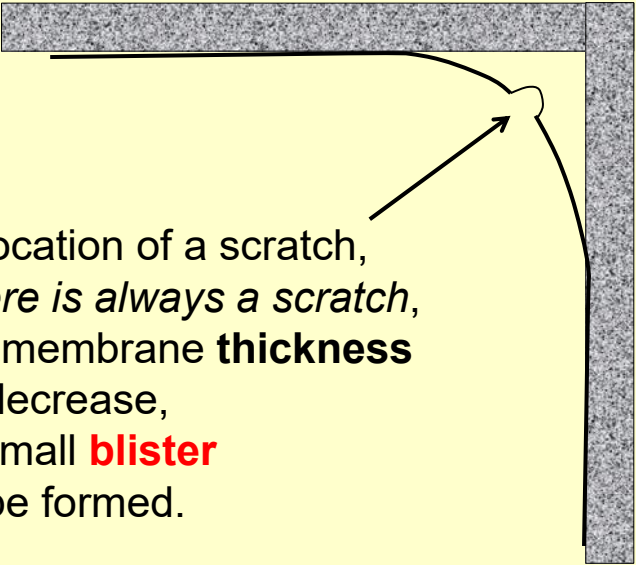
Finally, at the location of a scratch, *and there is always a scratch*, the geomembrane **thickness** would decrease, and a small **blister** would be formed.

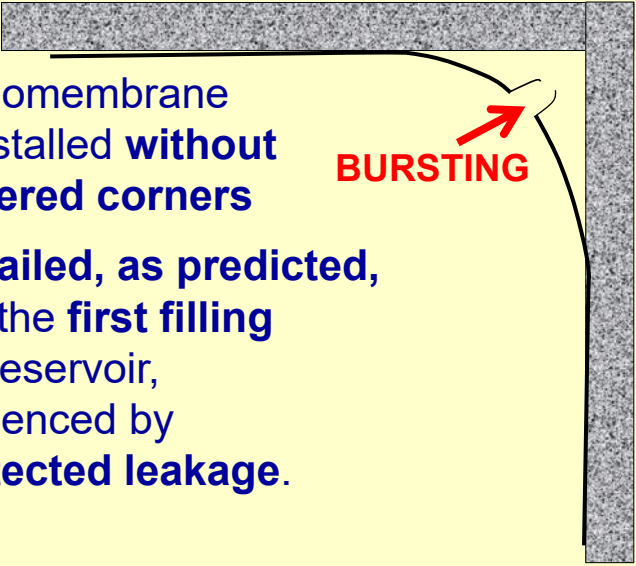
The geomembrane was installed **without chamfered corners** and it **failed, as predicted,** during the **first filling** of the reservoir, as evidenced by the **detected leakage**.

BURSTING

The diagram shows a cross-section of a concrete structure with a geomembrane lining. The corner is a sharp 90-degree angle. A red arrow points to a small hole in the geomembrane at the corner, labeled 'BURSTING'. The text explains that the failure occurred because the geomembrane was not installed with chamfered corners.

The **remediation** consisted in constructing the **chamfers** that had been initially recommended.

- Lightweight **concrete** was slowly poured **in the corners** between the rock-salt wall and the secondary geomembrane, thereby *using the geomembrane as a form*, **while water was progressively added** in the reservoir, as needed to balance the fresh concrete pressure.
- The reservoir was thus successfully repaired and filled with water at the same time.

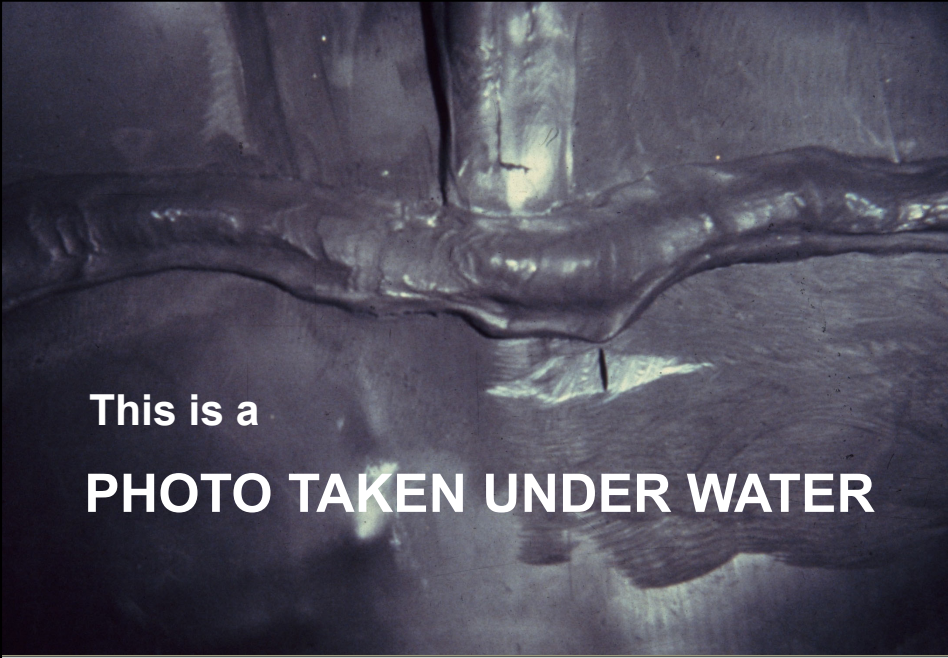
This is a **PHOTO TAKEN UNDER WATER**

The photograph shows a dark, underwater scene. A bright, circular light source is visible, creating a lens flare effect. The light illuminates a textured surface, likely the geomembrane, which appears to have a small hole or leak. The water is dark and slightly rippled.

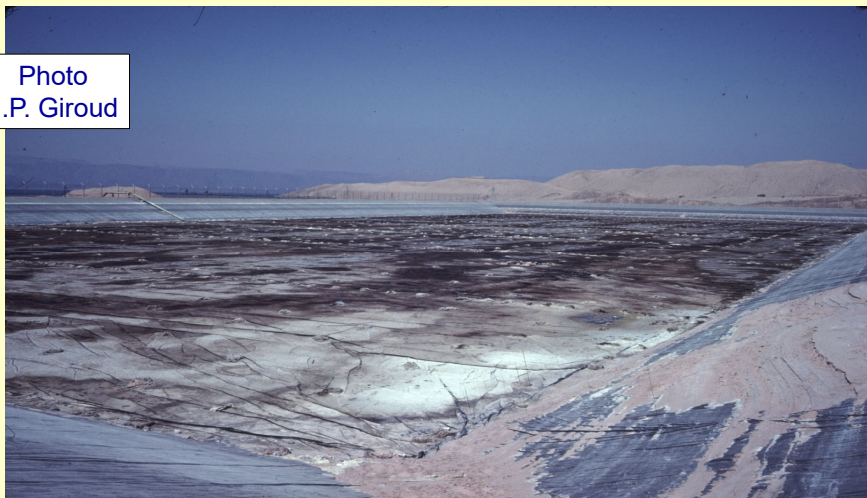
The reservoir emptied after the geomembrane **burst** over several **large cavities**.

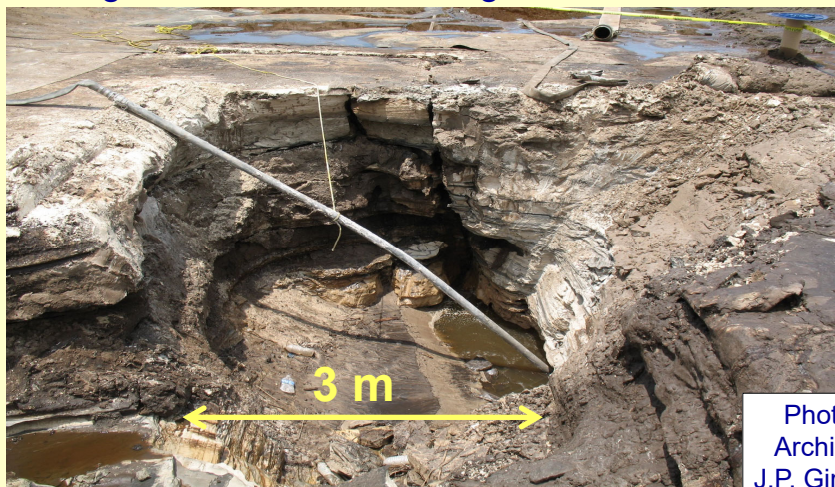
A **large cavity**, 20 m³, had slowly developed
at the bottom of the reservoir due to **leakage**
through a **small hole** in the geomembrane.

The geomembrane burst into the **20 m³** cavity
35 days after leakage started.

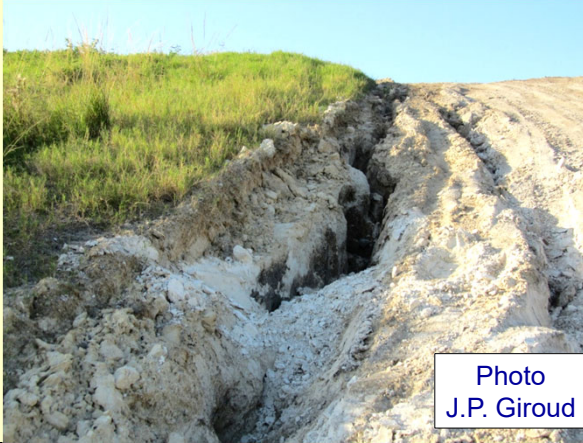
The cavity developed because the soil was **highly soluble** in water, especially salt water.

The **high solubility** and **erodability** of the soil was evidenced by deep gullies seen at the site.
