**SZÉCHY KÁROLY
MEMORIAL SESSION**

**DESIGN AND PERFORMANCE
OF
RESERVOIRS LINED
WITH
GEOMEMBRANES**

By
J.P. GIROUD
2017.02.10

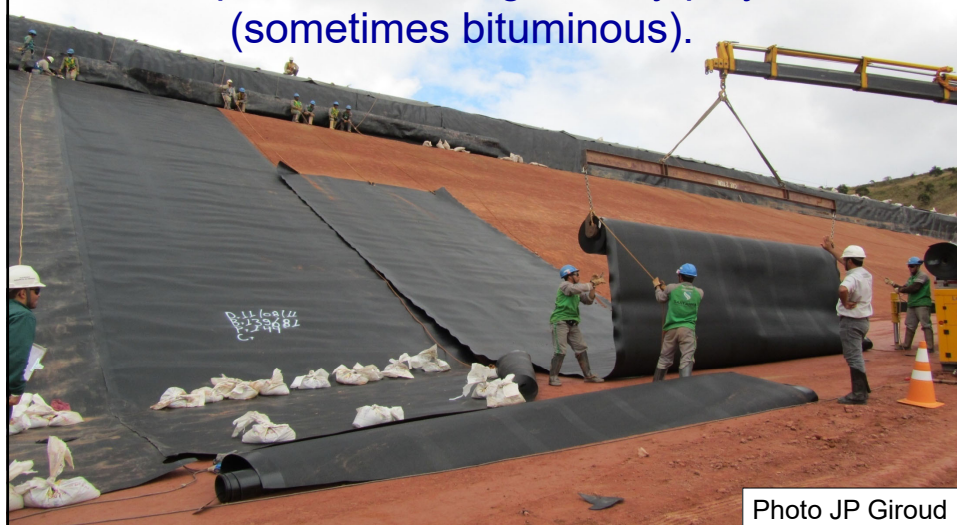
Geomembranes are thin and flexible sheets
of waterproof material, generally polymeric
(sometimes bituminous).

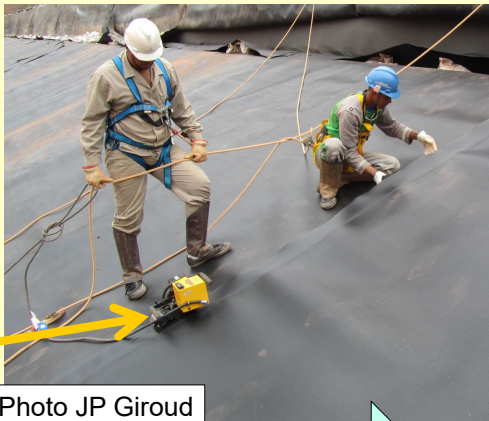
SEAMING MACHINE

Geomembrane panels are seamed together

to form large geomembrane liners used in a variety of applications.

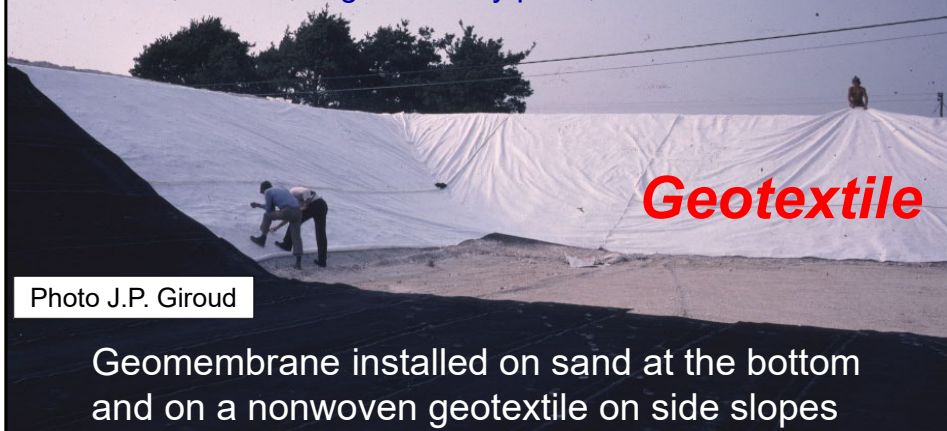
First use of a geotextile to protect a geomembrane
Connantre, France, sugar industry pond, 1971

Geomembrane installed on sand at the bottom
and on a nonwoven geotextile on side slopes

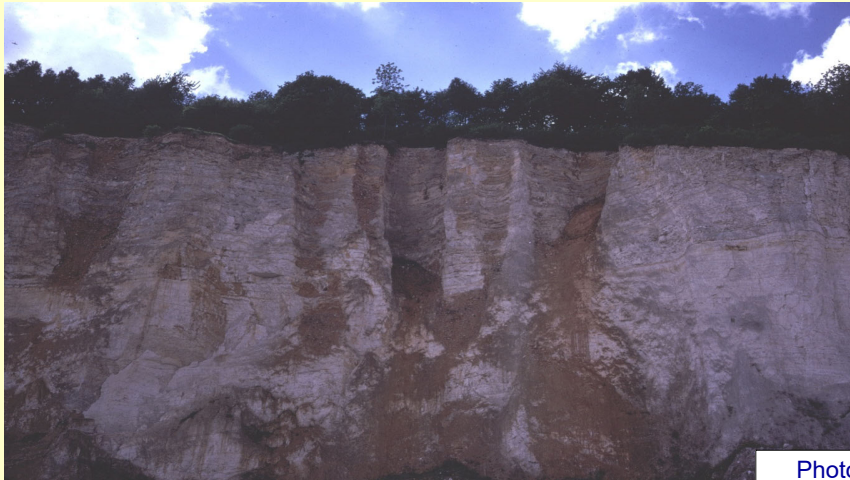
**The reservoir was located behind the trees,
not far from the quarry.**

Unfortunately, at the design stage,
no geological study was done
and the quarry was not observed.

The quarry was observed only
when the failure of the reservoir
was investigated.

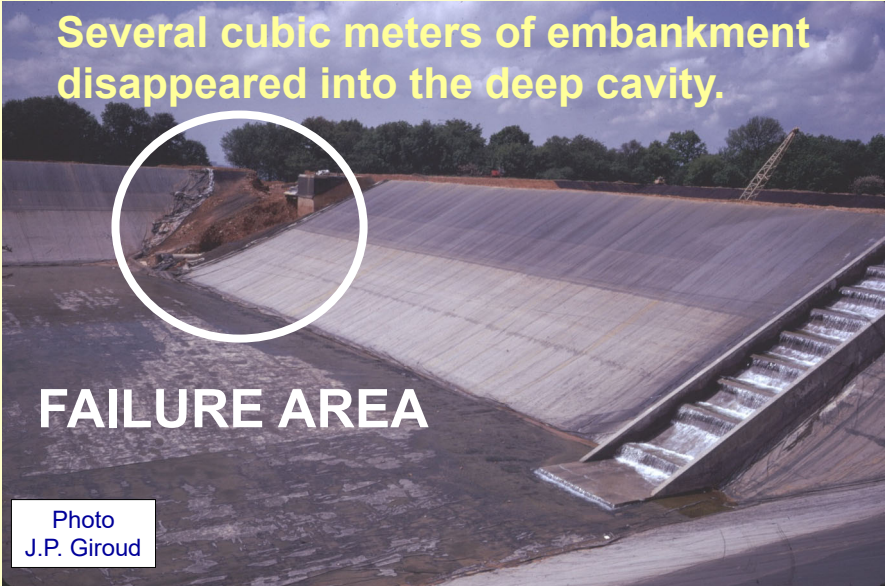
FAILURE AREA

View of the empty reservoir after failure

Several cubic meters of embankment disappeared into the deep cavity.

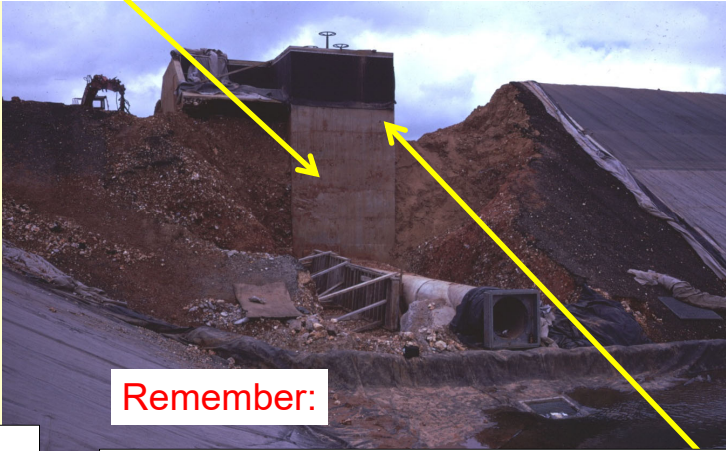
CLOSER VIEW OF THE FAILURE AREA

Concrete structure to which the geomembrane was attached.

The failure mechanism was initiated by a leak at the geomembrane-concrete connection.

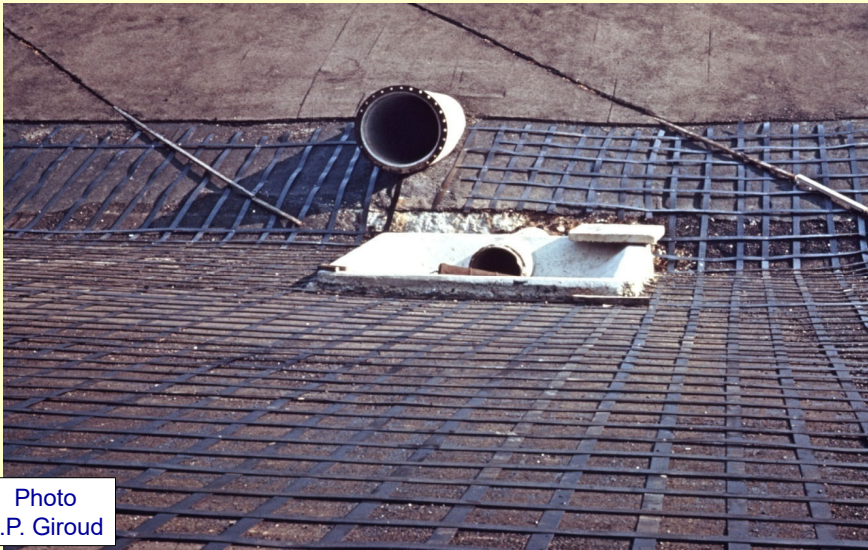
COMMENT ON THE REMEDIATION

- The most important aspect of the repair was the use of a **double liner** system, because it addressed the **cause of the problem**, which was leakage into the ground.
- The use of **reinforcement** only addressed the *consequence of leakage*, which was bursting of the geomembrane.

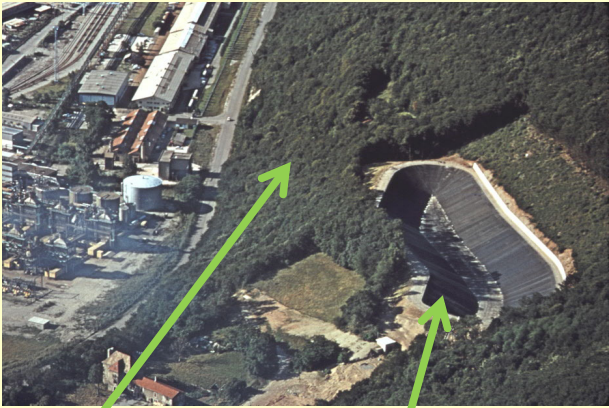
The water **reservoir** is located on a **steep slope**.

The **steep slope**

The **reservoir**

The geotechnical study showed that **leakage** from the reservoir could impair the **stability** of the slope.

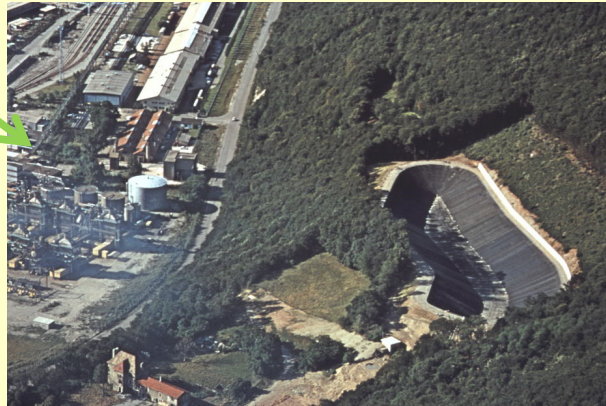
Here is
the
**chemical
plant**

Slope stability was essential
because there was a large **chemical plant**
at the toe of the steep slope,
50 meters lower than the reservoir.

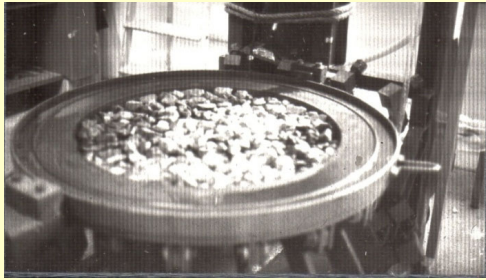
The selection of the geotextile protecting the geomembrane resulted from **pressure vessel tests** where the geomembrane/geotextile system was tested on a sample of the mortar-stabilized gravel.

Such tests were not common at the time (1973).

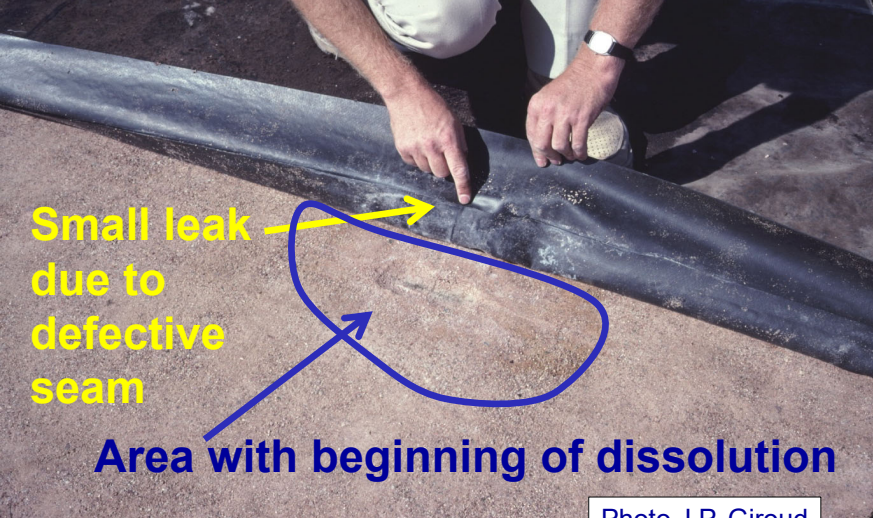
Dissolution of calcium carbonate by acid was clearly associated with leaks through the geomembrane.

Small leak due to defective seam

Area with beginning of dissolution

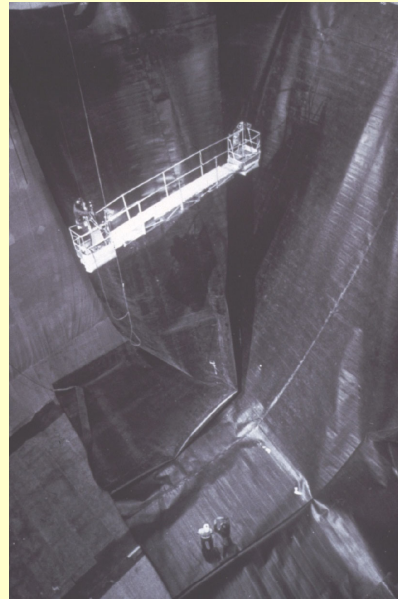
THE PROTON DECAY EXPERIMENT

A large volume of water
(about 8000 m³)
was needed
for a physics experiment
by a team
led by a Nobel prize winner
to evaluate the life span
of protons.

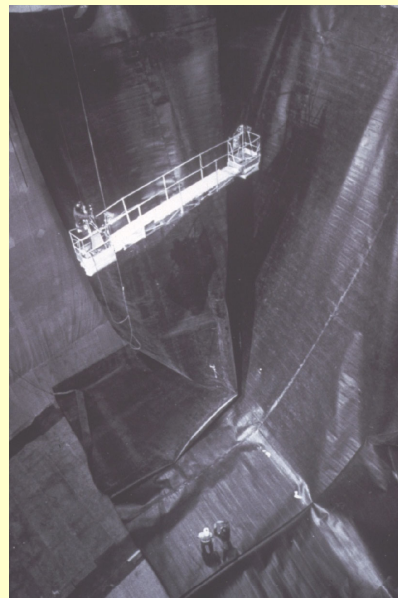
To contain the water required
by the physics experiment,
a large cavity
20 m x 20 m x 20 m
was excavated
in a **salt formation**
(because salt, contrary to rock,
is not radioactive)
600 m underground
(because cosmic radiation
does not penetrate that deep).

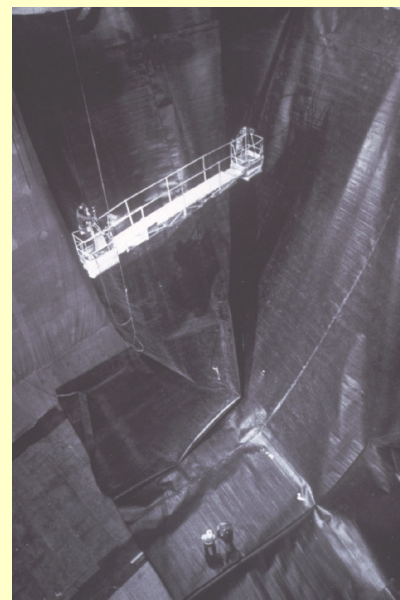
Due to the solubility of the salt, I recommended a **double liner** (i.e. two liners and a leakage collection and detection layer in between).

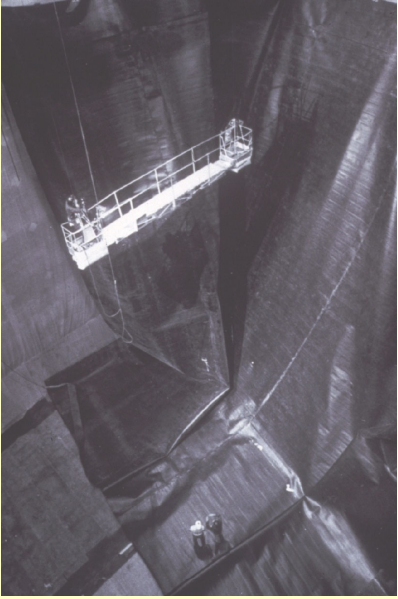
For the leakage collection and detection layer between the two geomembranes, I selected a **geonet** (a new geosynthetic at that time, 1980) because (contrary to gravel) it is **not radioactive** and could be **installed vertically**.

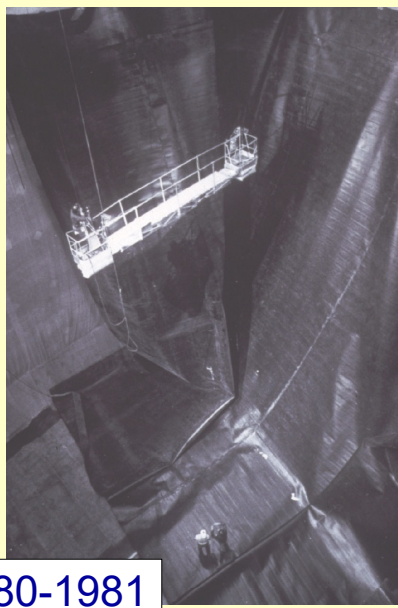
This was the **first use**
of a **geonet**
for a leakage collection layer
and the **first**
entirely geosynthetic
double liner system.

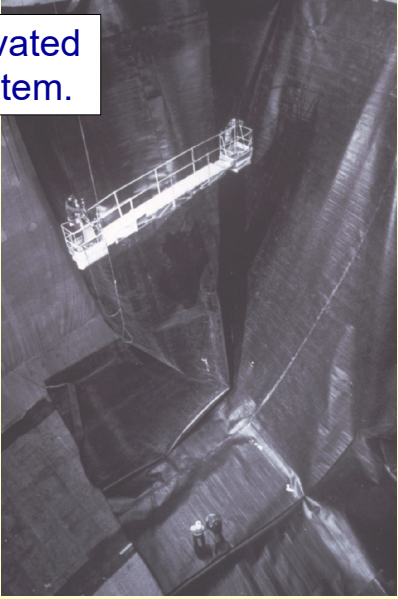
The corners of the reservoir were at **right angles**.

For me this was a difficult situation, and, to design the liner, I asked for the **stress-strain curve** of the geomembrane .

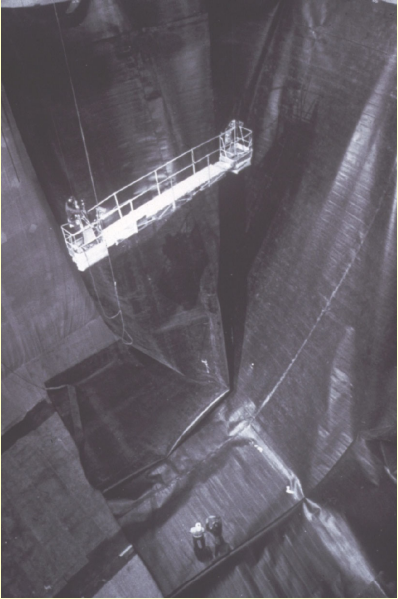
This was an extraordinary request at that time, and it was not easy to obtain the stress-strain curve for a geomembrane !

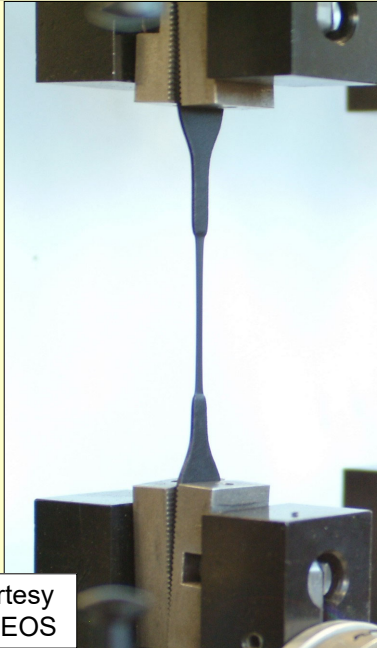
The **elongation** is **increased** until failure occurs.

A curve of **stress** as a function of **elongation** (“strain”) is obtained.

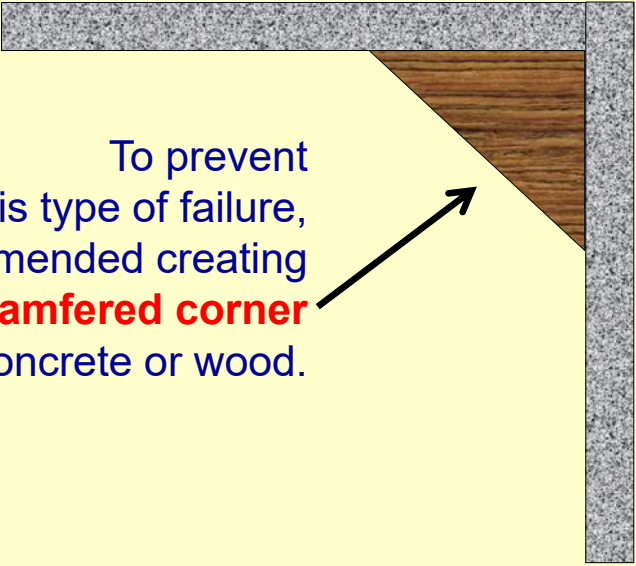
To prevent this type of failure, I recommended creating a **chamfered corner** using concrete or wood.

The diagram shows a cross-section of a concrete structure with a chamfered corner. The chamfer is filled with wood. An arrow points from the text to the wood-filled corner.

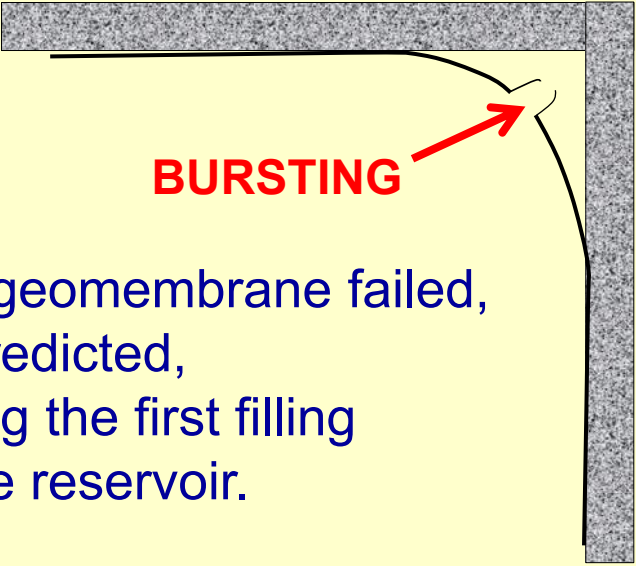
BURSTING

The geomembrane failed,
as predicted,
during the first filling
of the reservoir.
