**XXIII. Széchy Károly
Emlékkonferencia**

Design and Performance of Reservoirs Lined with Geomembranes

J. P. Giroud

Four case histories (in Europe, the Middle East and North America) are used to address some important aspects of the design and performance of geomembrane-lined reservoirs excavated in soil and rock. After a brief introduction to geomembranes and related geosynthetics, a first case history presents the failure of the geomembrane liner of a reservoir located in karstic terrain. The following lessons were learned: a defective construction detail combined with an inadequate design (due in part to ignorance of the geological and geotechnical conditions) can cause a catastrophic failure. This case history led to the development of the double liner concept. The case history of the first double liner with two geomembranes is then presented. This case shows that adequate design is essential to control leakage, which makes it possible to construct a safe reservoir on a potentially unstable soil. A third case history shows that a “zero-leakage guarantee” offered by irresponsible suppliers, and believed by uninformed owners, can lead to catastrophic failure. This case history

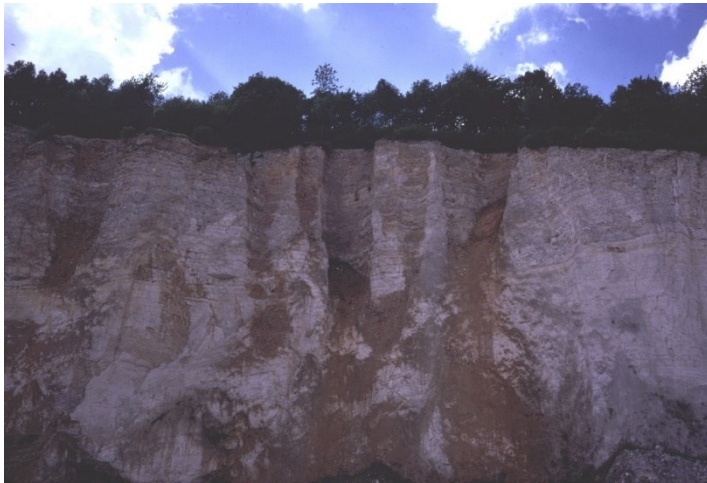
Figure 1. Side view of the karstic formation from an abandoned quarry located near the reservoir.

A reservoir for water storage was constructed on a layer of natural soil, only a few meters thick, overlying a karstic formation. A karstic formation is a mass of limestone that includes cavities. These cavities are either empty or partly filled with soil. The reservoir was close to an abandoned quarry which provided an opportunity to see the karstic formation (Figure 1). Numerous cavities could thus be observed. The soil layer on top of the limestone was thin. Unfortunately, at the design stage, no geological study was performed and the quarry was not observed. The quarry was observed only when the failure of the reservoir was investigated. As a result, the designer of the reservoir ignored the presence of the karstic formation hidden by a thin layer of soil.

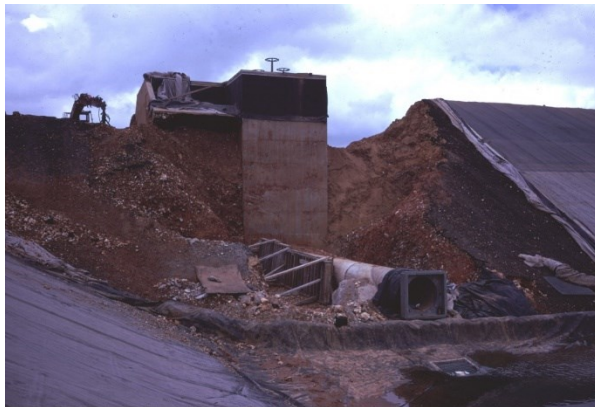
Figure 5. View of the failure area and the concrete structure.

This resulted in massive leakage. The reservoir emptied rapidly after the failure. Several cubic meters of embankment disappeared into the deep cavity (Figure 5).

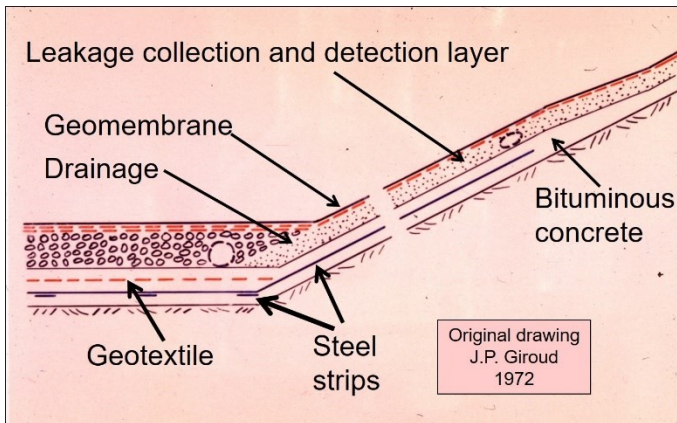
Figure 6. Cross section of the double liner system used to repair the reservoir.

The remediation consisted in replacing the single geomembrane by a double liner with a geomembrane as the primary liner and bituminous concrete as the secondary liner (Figure 6). The function of the secondary liner (i.e. the liner located under the leakage collection and detection layer) was to prevent water collected by the leakage collection and detection layer from infiltrating into the ground.

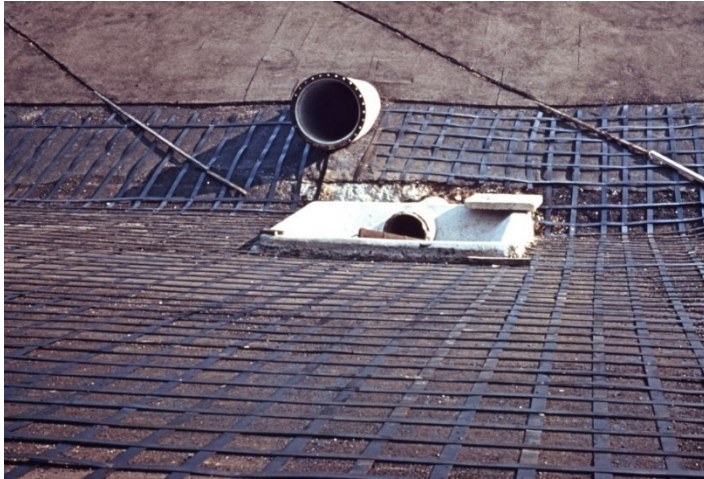
Figure 7. Steel reinforcement used in the secondary liner made of bituminous concrete.

A new butyl rubber geomembrane (identical to the original one) was used as the primary liner. The leakage collection and detection layer consisted of gravel (which, on the side slopes, was stabilized with bitumen). As a precaution, the bituminous concrete secondary liner was reinforced to prevent eventual collapsing of the liner system into a cavity. Reinforcement was achieved by using between two layers of bituminous concrete: (1) a layer of nonwoven geotextile; and (2) two layers of steel strips at right angle (Figure 7). While the effectiveness of a nonwoven geotextile reinforcement in bituminous concrete is questionable, the use of two layers of steel strips (of the type used in mechanically stabilized earth walls) was probably overconservative.

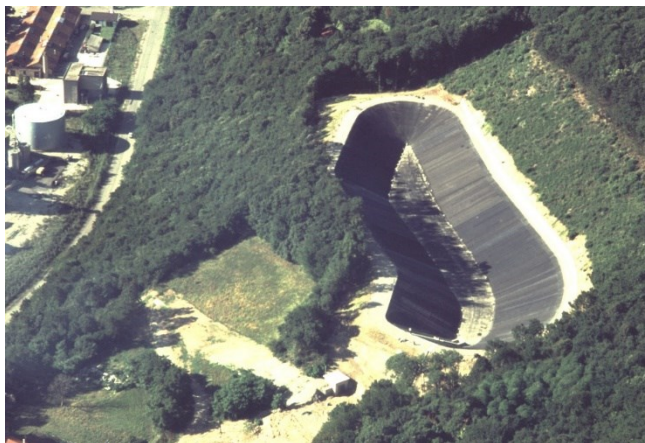
Figure 8. Reservoir on a 50 m high steep slope.

toe of the steep slope, 50 meters lower than the reservoir (Figure 8). To minimize leakage into the ground, a double liner system was selected. The primary liner is a butyl rubber geomembrane and the secondary liner is a bituminous geomembrane. The leakage collection and detection layer is a layer of rounded gravel stabilized with a small amount of mortar and placed directly on the bituminous geomembrane (Figure 9). A nonwoven geotextile was used as a protection between the primary liner geomembrane and the gravel.

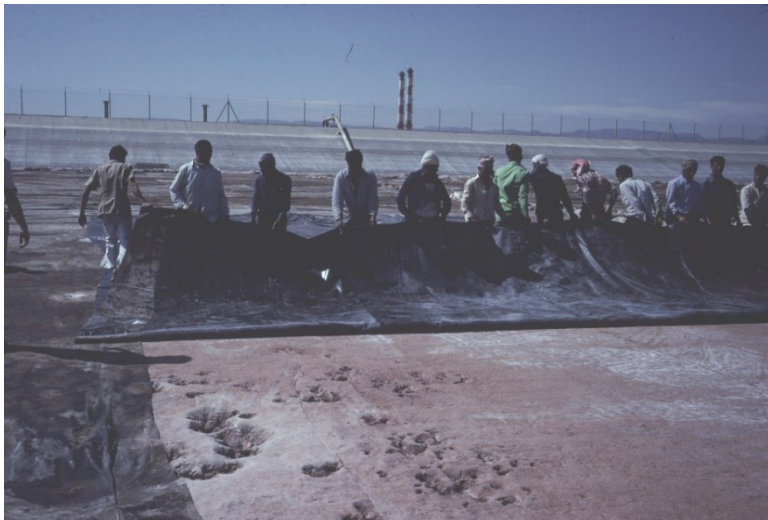
Figure 10. Cavities caused by several leaks of acid.

Inspection after the failure showed that the geomembrane had many holes (open seams, punctures, tears) due to careless construction. It was clear that the geomembrane had to be discarded and that a new geomembrane had to be installed. When the geomembrane was removed, many cavities were found (Figure 10).

These cavities resulted from dissolution by phosphoric acid of calcium carbonate contained in the soil. Comparative inspection of the geomembrane and the soil showed that dissolution of calcium carbonate by acid was clearly associated with leaks through the geomembrane. Small leaks were associated with limited dissolution of the soil, whereas large leaks were associated with large cavities, up to 1 m in diameter (Figure 11).

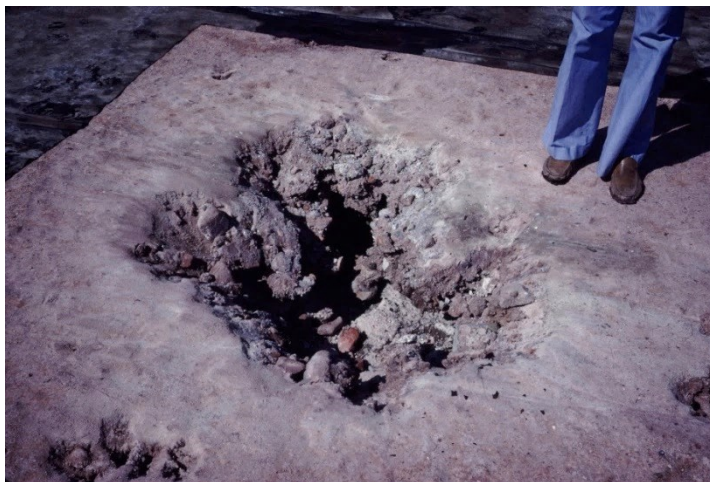
Figure 11. A large cavity over which the geomembrane burst.

As part of the investigation of the failure, a calculation was done using the methodology presented in Giroud (1982, p.42). This calculation, using the tensile properties of the geomembrane, showed that this geomembrane would burst, under the pressure exerted by 6 m of water, over a cavity having a diameter of approximately 1 m. This result is in agreement with the observed failure.

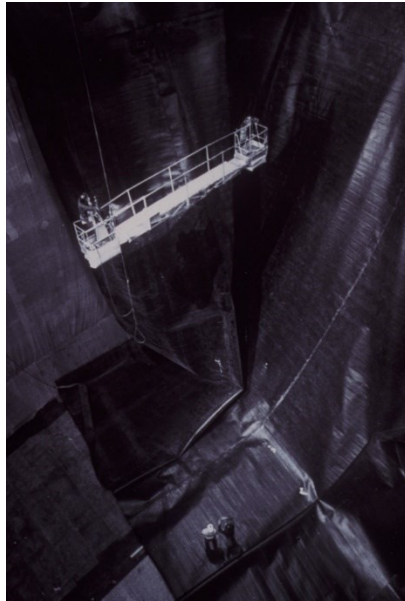
Figure 13. The cavity during geomembrane liner installation.

A large volume of water (about 8000 m³) contained in a geomembrane-lined cavity (Figure 13) was needed for “The Proton Decay Experiment”, a fundamental physics project implemented by a team led by a Nobel prize winner to evaluate the life span of protons. As the proton life span was predicted to be 10³² years, ten protons were expected to decay every year in this volume of water. The reservoir was to contain the purest water ever produced in order to detect the faint light given off by decaying protons.

The 20 m × 20 m × 24 m cavity with vertical walls was excavated in a salt formation (because salt, contrary to rock, is not radioactive) 600 m underground (because cosmic radiation does not penetrate that deep) to contain the water required by the physics experiment. Both radioactivity and cosmic radiation would have disturbed the experiment.

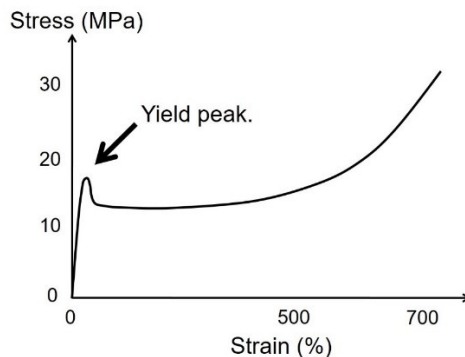
**Figure 14. Stress-strain curve of HDPE geomembrane.
Recommended remedial measure**

Upon inspection of the stress-strain curve, the design engineer realized that there was a yield peak on the curve, which was a surprise since no other geomembrane known at that time had a yield peak on its stress-strain curve (Figure 14). The yield peak occurred at a tensile strain of approximately 12% whereas the strain at break of the HDPE geomembrane (i.e. the end of the stress-strain curve) was approximately 700%.

The design engineer understood that any irregularity of the surface of the geomembrane (e.g. a scratch or a seam between two geomembrane panels) would cause the yield strain to be reached in a small part of the geomembrane while the strain in the rest of the geomembrane is still lower than the yield strain. In other words, the geomembrane would be in a plastic state in a small area and remain in the elastic state everywhere else. As a result, the strain in the geomembrane would drastically increase to several hundred percent in a small area. This would cause localized thinning of the geomembrane until it burst under water pressure. It is important to note that, while the strain would be several hundred percent in the failure area, the average strain over the entire geomembrane area subjected to tension is close to the yield strain. In other words, failure occurs for an average strain of the order of 12%, not 700%.

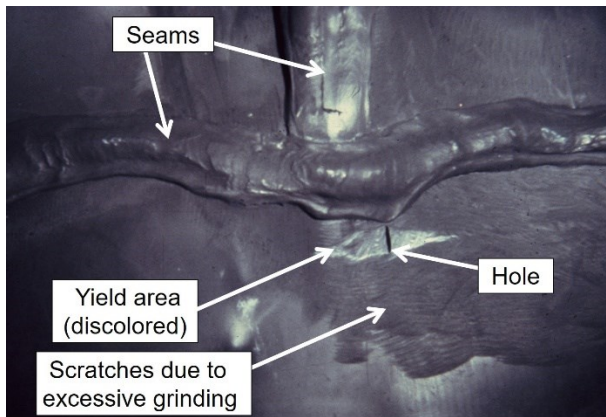
Figure 16. Under water photo showing the failure.

Photos taken under water (which, being extremely pure, was transparent) showed that the geomembrane had burst in a scratched area near a seam (Figure 16). It should be noted that scratches and seams were the two causes of potential strain concentration identified at the design stage. Scratches had been caused by a seaming procedure that consisted in grinding the geomembrane surface prior to seaming. This procedure has been improved since then.

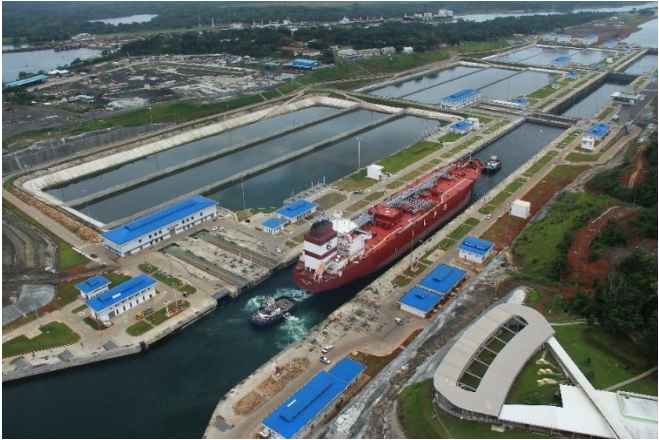
Figure 17. Water reservoirs for the Panama Canal locks [Courtesy Carpi].

Examples of large reservoirs, canals and dams that have been successfully constructed with a geomembrane liner are illustrated in Figures 17 to 19. It should be noted that in these impressive structures the geomembrane liner is the sole waterproof component,

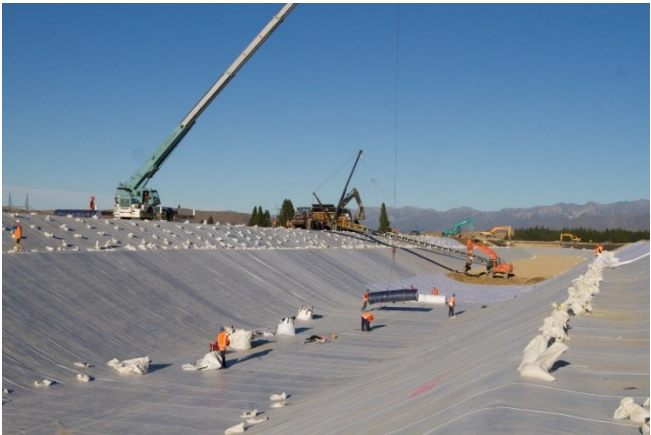
Figure 18. Tekapo canal in New Zealand [Courtesy Carpi].

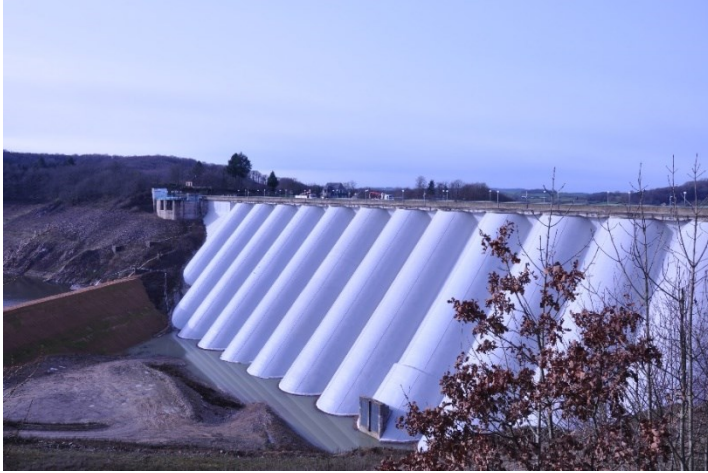
Figure 19. Pannecière Dam in France [Courtesy Carpi].
