First double geomembrane liner *40 years later*

The first double geomembrane liner 40 years later

By J.P. Giroud and J.P. Gourc

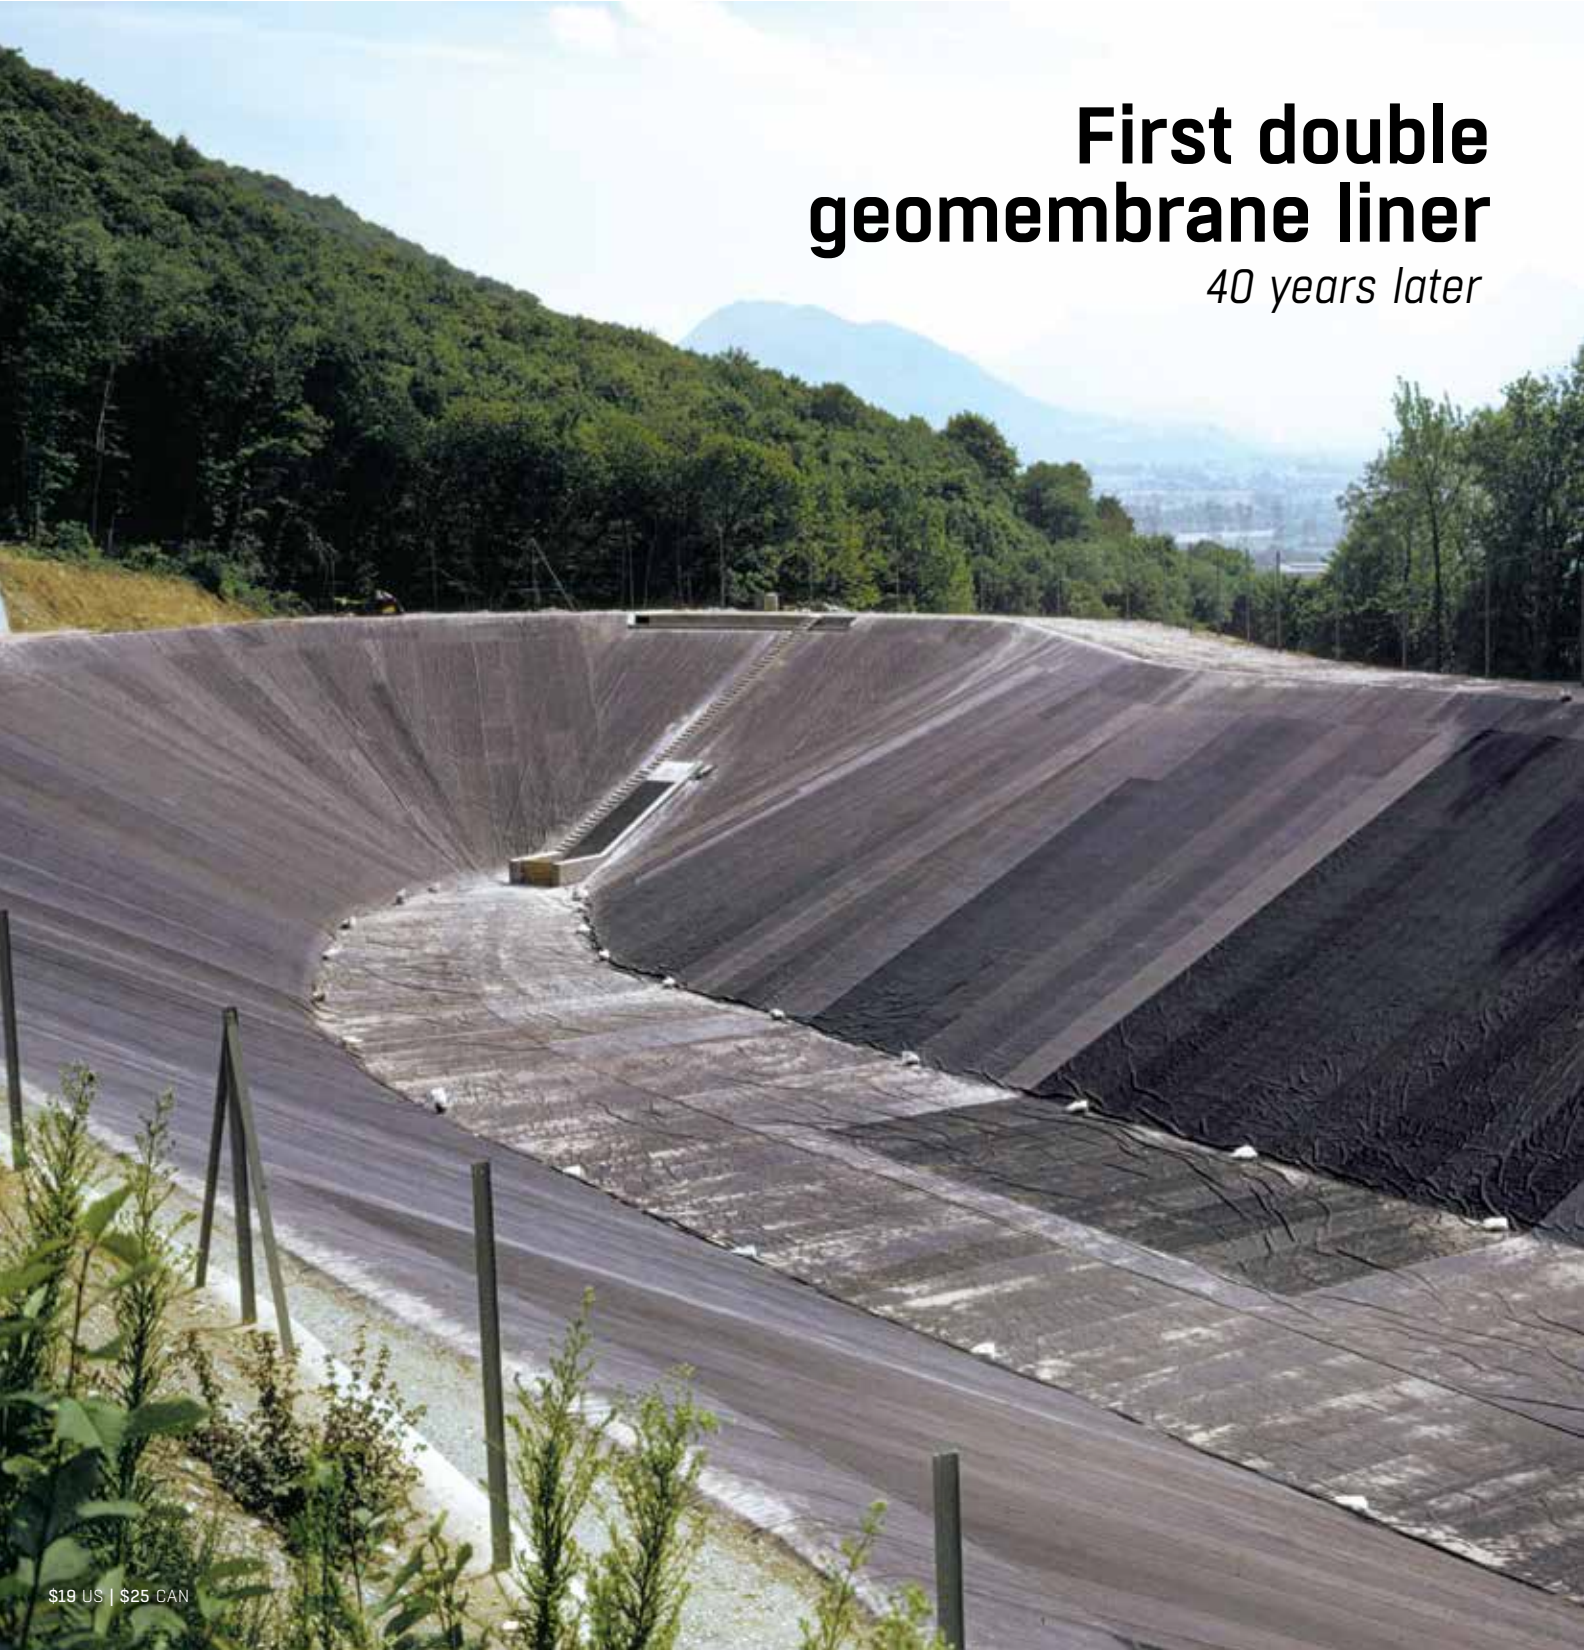
FIGURE 14 The reservoir in 2011, 37 years after construction and beginning of service.

The authors visited the site with A.L. Rollin in September 2011, 37 years after construction. The reservoir was full (i.e., the water level was 1m vertical below the crest) (**Figure 14**). The reservoir has never been emptied and the portion of butyl rubber geomembrane above water has been continuously exposed since 1974. As indicated above and in **Figure 3**, the emerged portion of the geomembrane, the only portion of geomembrane visible during the site visit, is reinforced with scrim.

The butyl rubber geomembrane appeared to be in good condition. It did not seem brittle and it did not exhibit visible cracks. Only one hole (about 1cm²) was seen (Figure 15), at the south end of the reservoir, in the horizontal portion of the geomembrane between the top of the slope and the anchor trench. The reinforcing fabric (scrim) was visible at the edge of the hole. No other mechanical damage was observed.

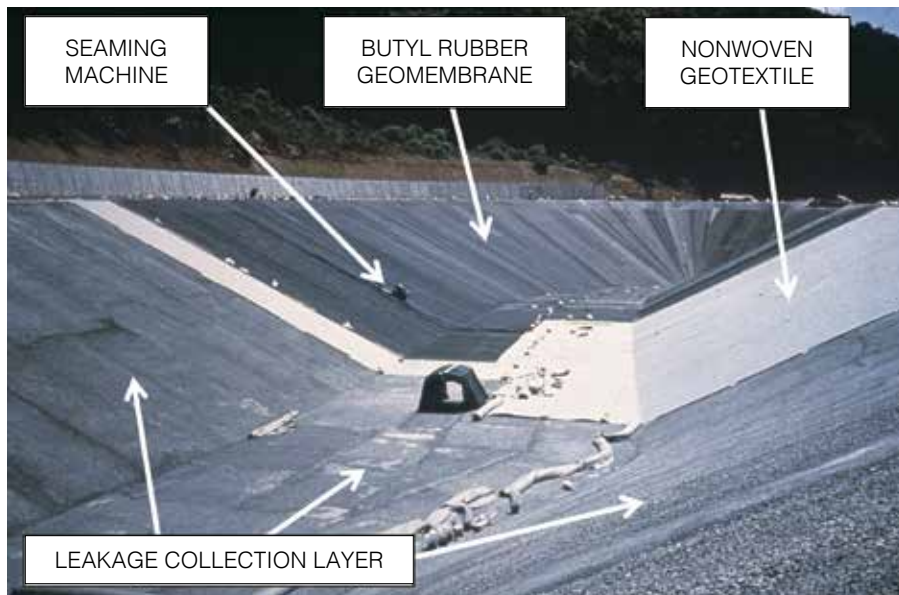
The geomembrane was installed in the summer of 1974 by Fipecc on a polyester, needle-punched, nonwoven geotextile (**Figure 10**). At that time, there was already three years of experience with the use of geotextiles to protect geomembranes. The completed installation can be seen in **Figures 2, 3, and 11**. The butyl rubber geomembrane and the geotextile are secured in an anchor trench, 0.2m deep by 0.5m wide, located at a 0.5m horizontal distance from the top of the slope.

FIGURE 10 Installation of the butyl rubber geomembrane primary liner on a geotextile.

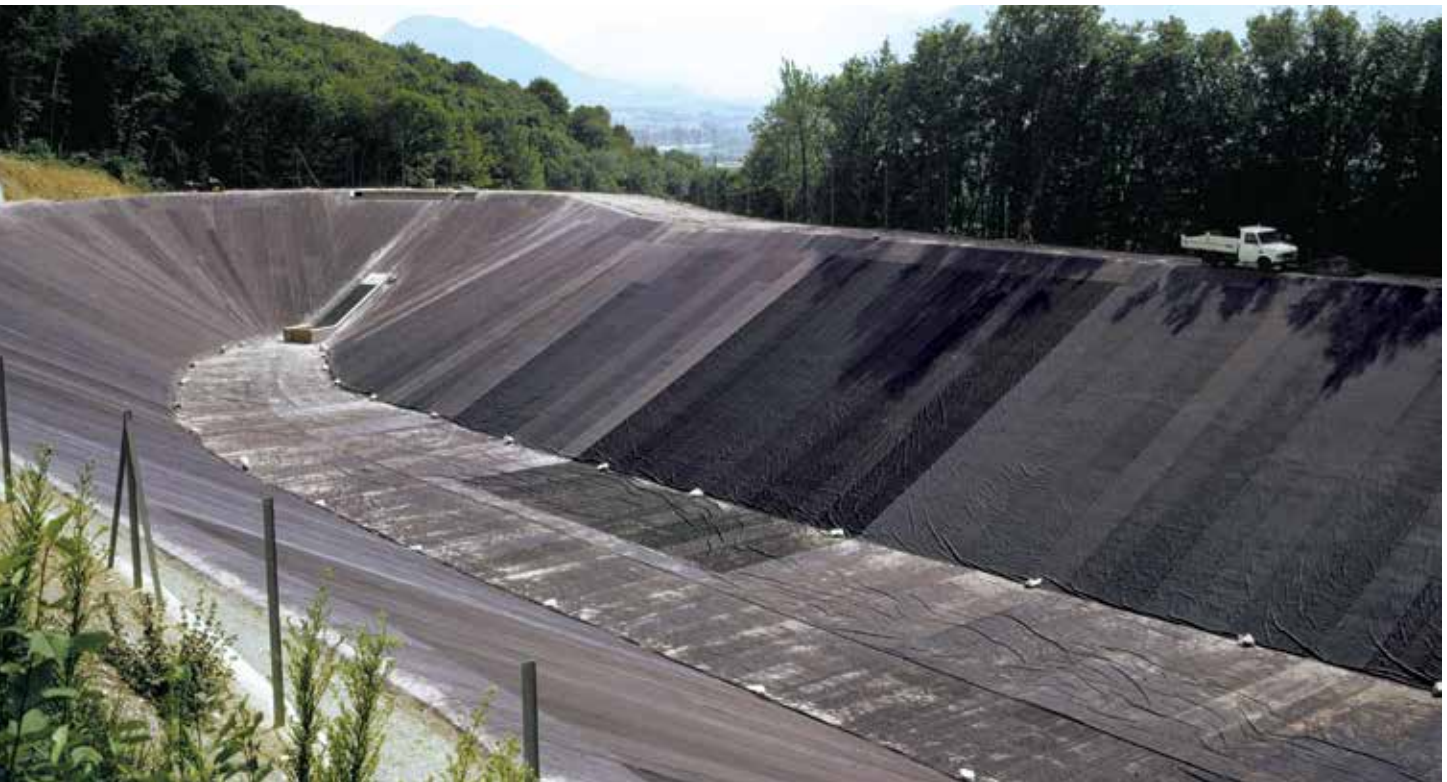
FIGURE 11 Completed installation of the butyl rubber geomembrane primary liner.

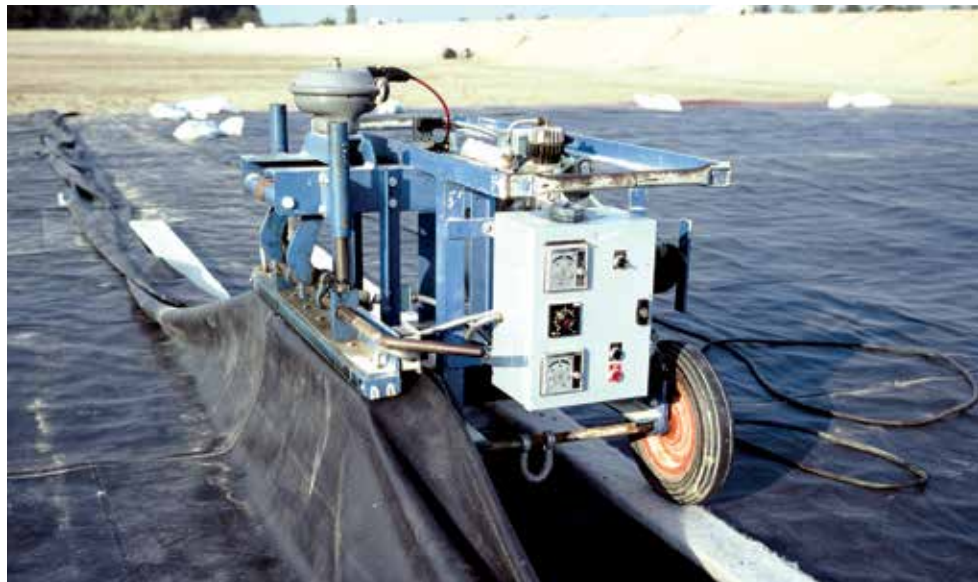
FIGURE 13 Butyl rubber geomembrane seaming machine (photo taken at a different site in the 1970s). The same machine is seen on the slope in Figure 10. The seaming configuration shown in Figure 12 was used both in the factory and in the field with the same jaw size.
